## TRAINING COURSE IN MOSAIC RESTORATION

Madaba JORDAN - Shahba SYRIA - Jerusalem PALESTINE  
August - September 2003

**Prepared by:  
Osama Hamdan - Carla Benelli  
CISS**

**March - 2004**

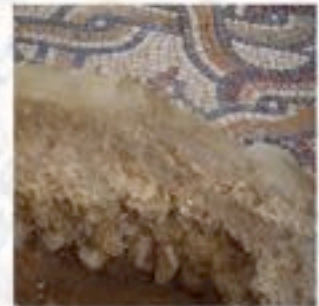
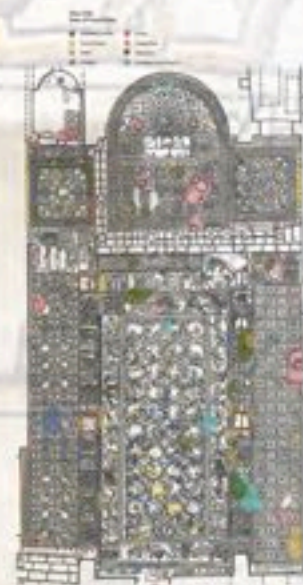
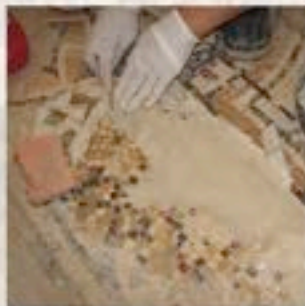
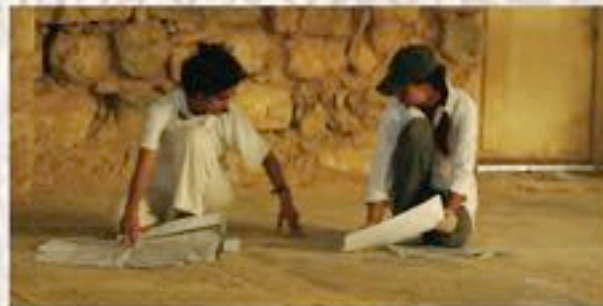
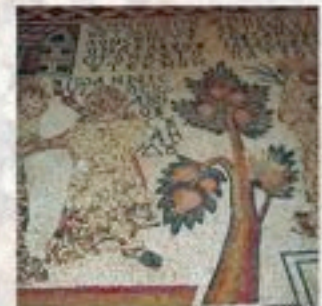
2. Studies and analysis of the state of conservation of the mosaics, recording it over existing graphic documents. As a result of this activity, the following problems were underscored:

- crumbling tesserae
- loose tesserae
- patina
- swelling
- lacunae
- cement strips
- depression
- chromatic variation by fire

- Filling the existing lacunae by compatible mortar
- Removing of incompatible material (cement in lacunae and mortar strips)
- Setting of mortar strip by compatible materials
- Consolidation by Primal
- Reinforcing of sections where different levels of mosaic are exposed
- Cleaning of the entire surface from dust and light concretions and from bird excrements
- Taking measures of protection against birds entering the site
- Consolidation of some plaster walls

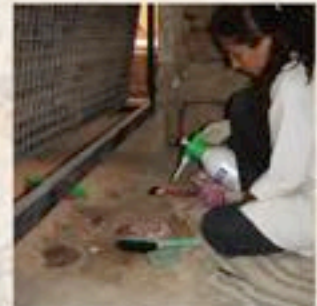
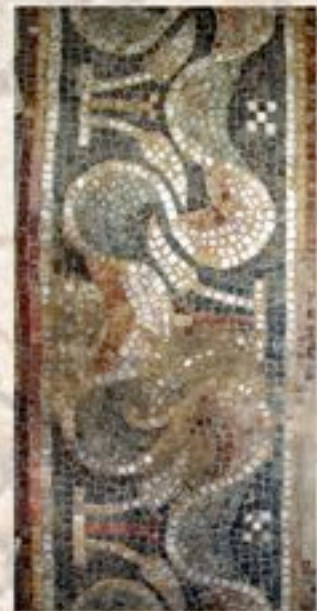
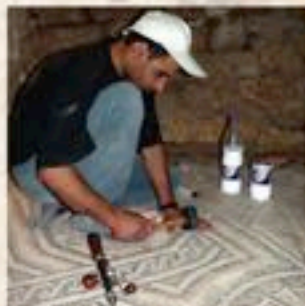
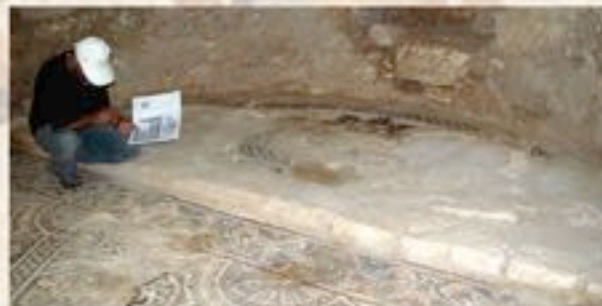
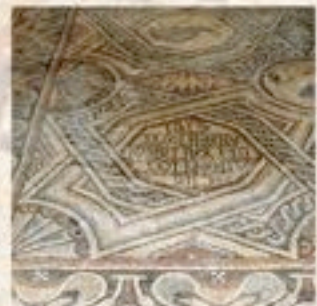
1. Collection of already existing historical, graphic and photographic documentation and past restoration reports concerning the Crypt.
2. Studies and analyses of the state of conservation of mosaics and walls, recording it over already existing graphic documentation.

3. Intervention of maintenance over the mosaics, carrying out the following activities:
  - a. Removal of materials (cement and metallic nails) incompatible with original ones

- b. Consolidation of mosaic borders through the installation of compatible mortar strips
  - c. Consolidation and fixing of loose tesserae
  - d. Consolidation and installation of mortar strips inside the lacunae of the mosaic (in the statumen) by compatible materials

- e. Consolidation works in the swelling by injection
  - f. Integration of small lacunae in the mosaic by natural mortar
  - g. Cleaning of the entire mosaic surface and removal of dust deposit

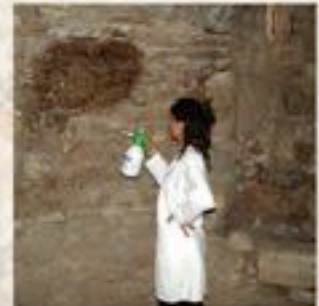
4. During the intervention we noticed that the huge dust and earth deposit over the mosaic surface was due to the bad condition of walls. So we decided to consolidate the degraded parts of stones, plaster and to intervene also among joints of the walls of the Crypt, to stop the degradation and at the same time to preserve the mosaic in the best way. This intervention was new for the trainees, because they had no previous experience in consolidation of wall structures. It was part of the training process to define causes of degradation and understand how to intervene directly over them to solve the problems which affect, in indirect ways, the mosaics.

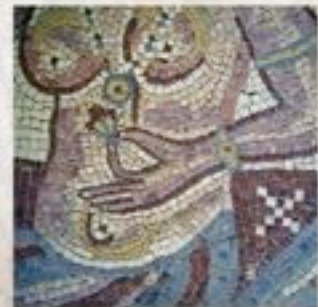
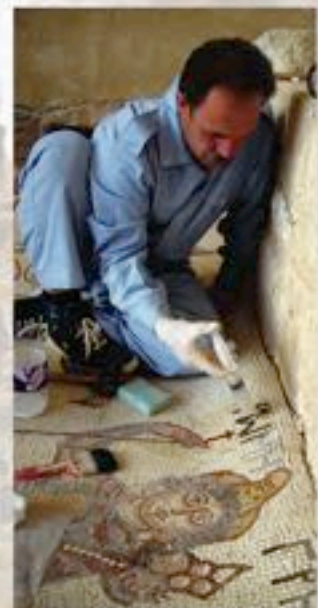
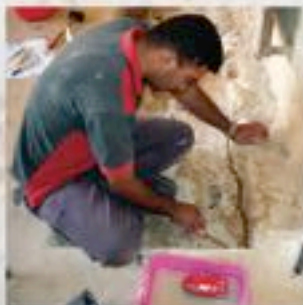
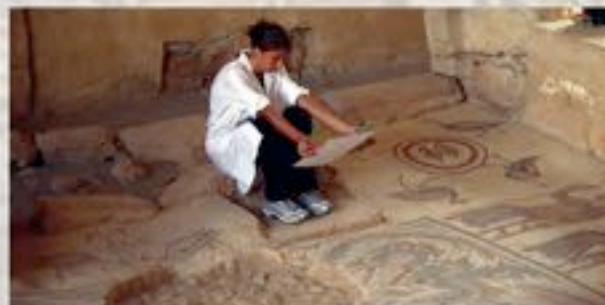
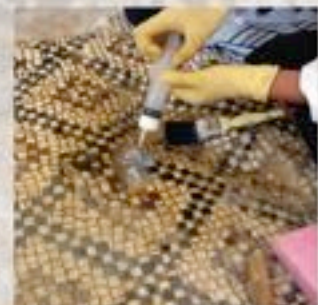
As result of the process of studies and analyses over the state of conservation, what emerges is that the mosaics were suffering from:

- lacunae, some of which filled by cement during previous intervention. The lacunae had their borders consolidated by cement and were big in dimension in the southern part of the mosaic.
- detachment of the mosaic from its original bed, especially around the borders of the mosaic.
- loose tesserae
- presence of delamination in the north-west part of the mosaic
- limited swelling along the borders, in the western part of the mosaic
- cracks of medium and small size, spread all over the surface
- crumbling tesserae were spread all over the surface
- fracturing tesserae were spread all over the surface

- a. removal of incompatible material (cement)
- b. consolidation and fixing of mosaic borders by setting of strips made by compatible material
- c. consolidation and fixing of loose tesserae
- d. consolidation by injection
- e. cleaning of the entire surface and removal of dust deposit
- f. consolidation of the mosaic bed, into the lacunae
- g. consolidation of the walls of the original structure, especially in the southern and northern parts, by injection to consolidate original plaster and mortar and by strip mortar

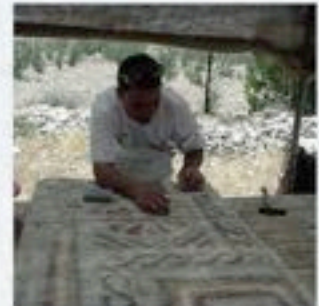
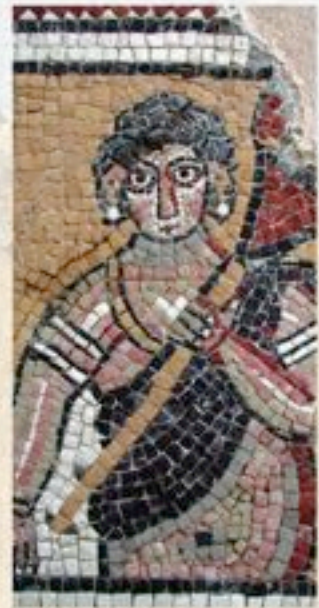
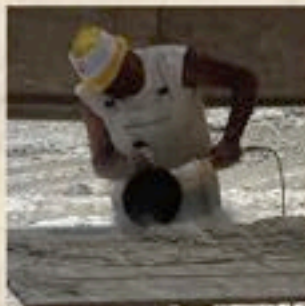
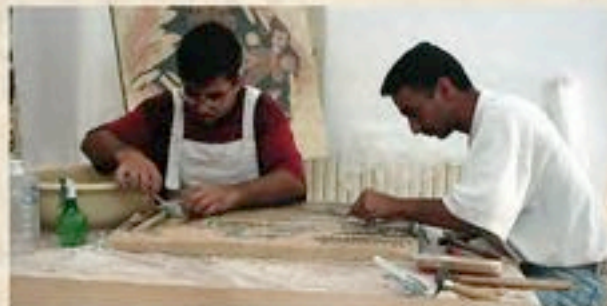
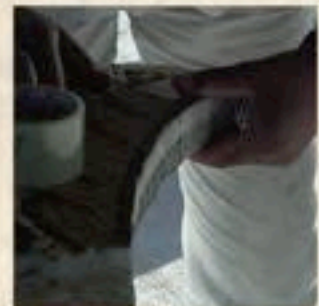
Due to the severe state of degradation of the mosaic floor - more than 40% of the original mosaic had already been destroyed - in 1977, the archaeological expedition directed by Father Michele Piccirillo removed the mosaic from its original location to prevent further damage, and relaid it on a reinforced concrete bed.

The mosaic was in extreme need of restoration. Bibliographical research was conducted over the site, the mosaic and its state of conservation was documented.

The restoration work was carried out in four phases, and it is still on. Various panels of the central nave of the mosaic floor, including the surrounding meander, were recovered from storage, washed, mapped and removed from cement bed. Then panels were relaid on aluminum supports of Aerolam.

Part of the restoration work was conducted in the laboratory of the Madaba School, to fix all the panels into the original position. The original design was drawn over plastic sheet following old photographic materials.

Then the restored panels were positioned over it. The void spaces among them were closed by compatible material and lost areas of the design were drawn by watercolors.

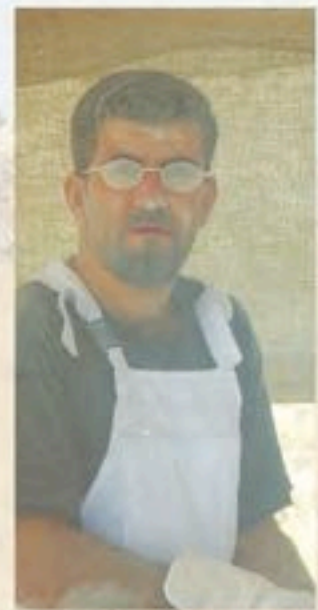
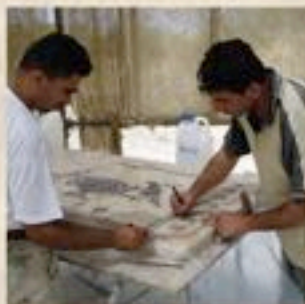
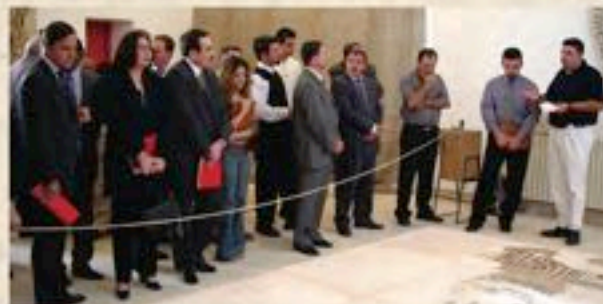
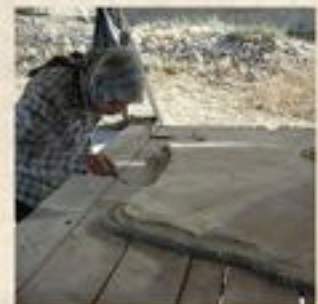
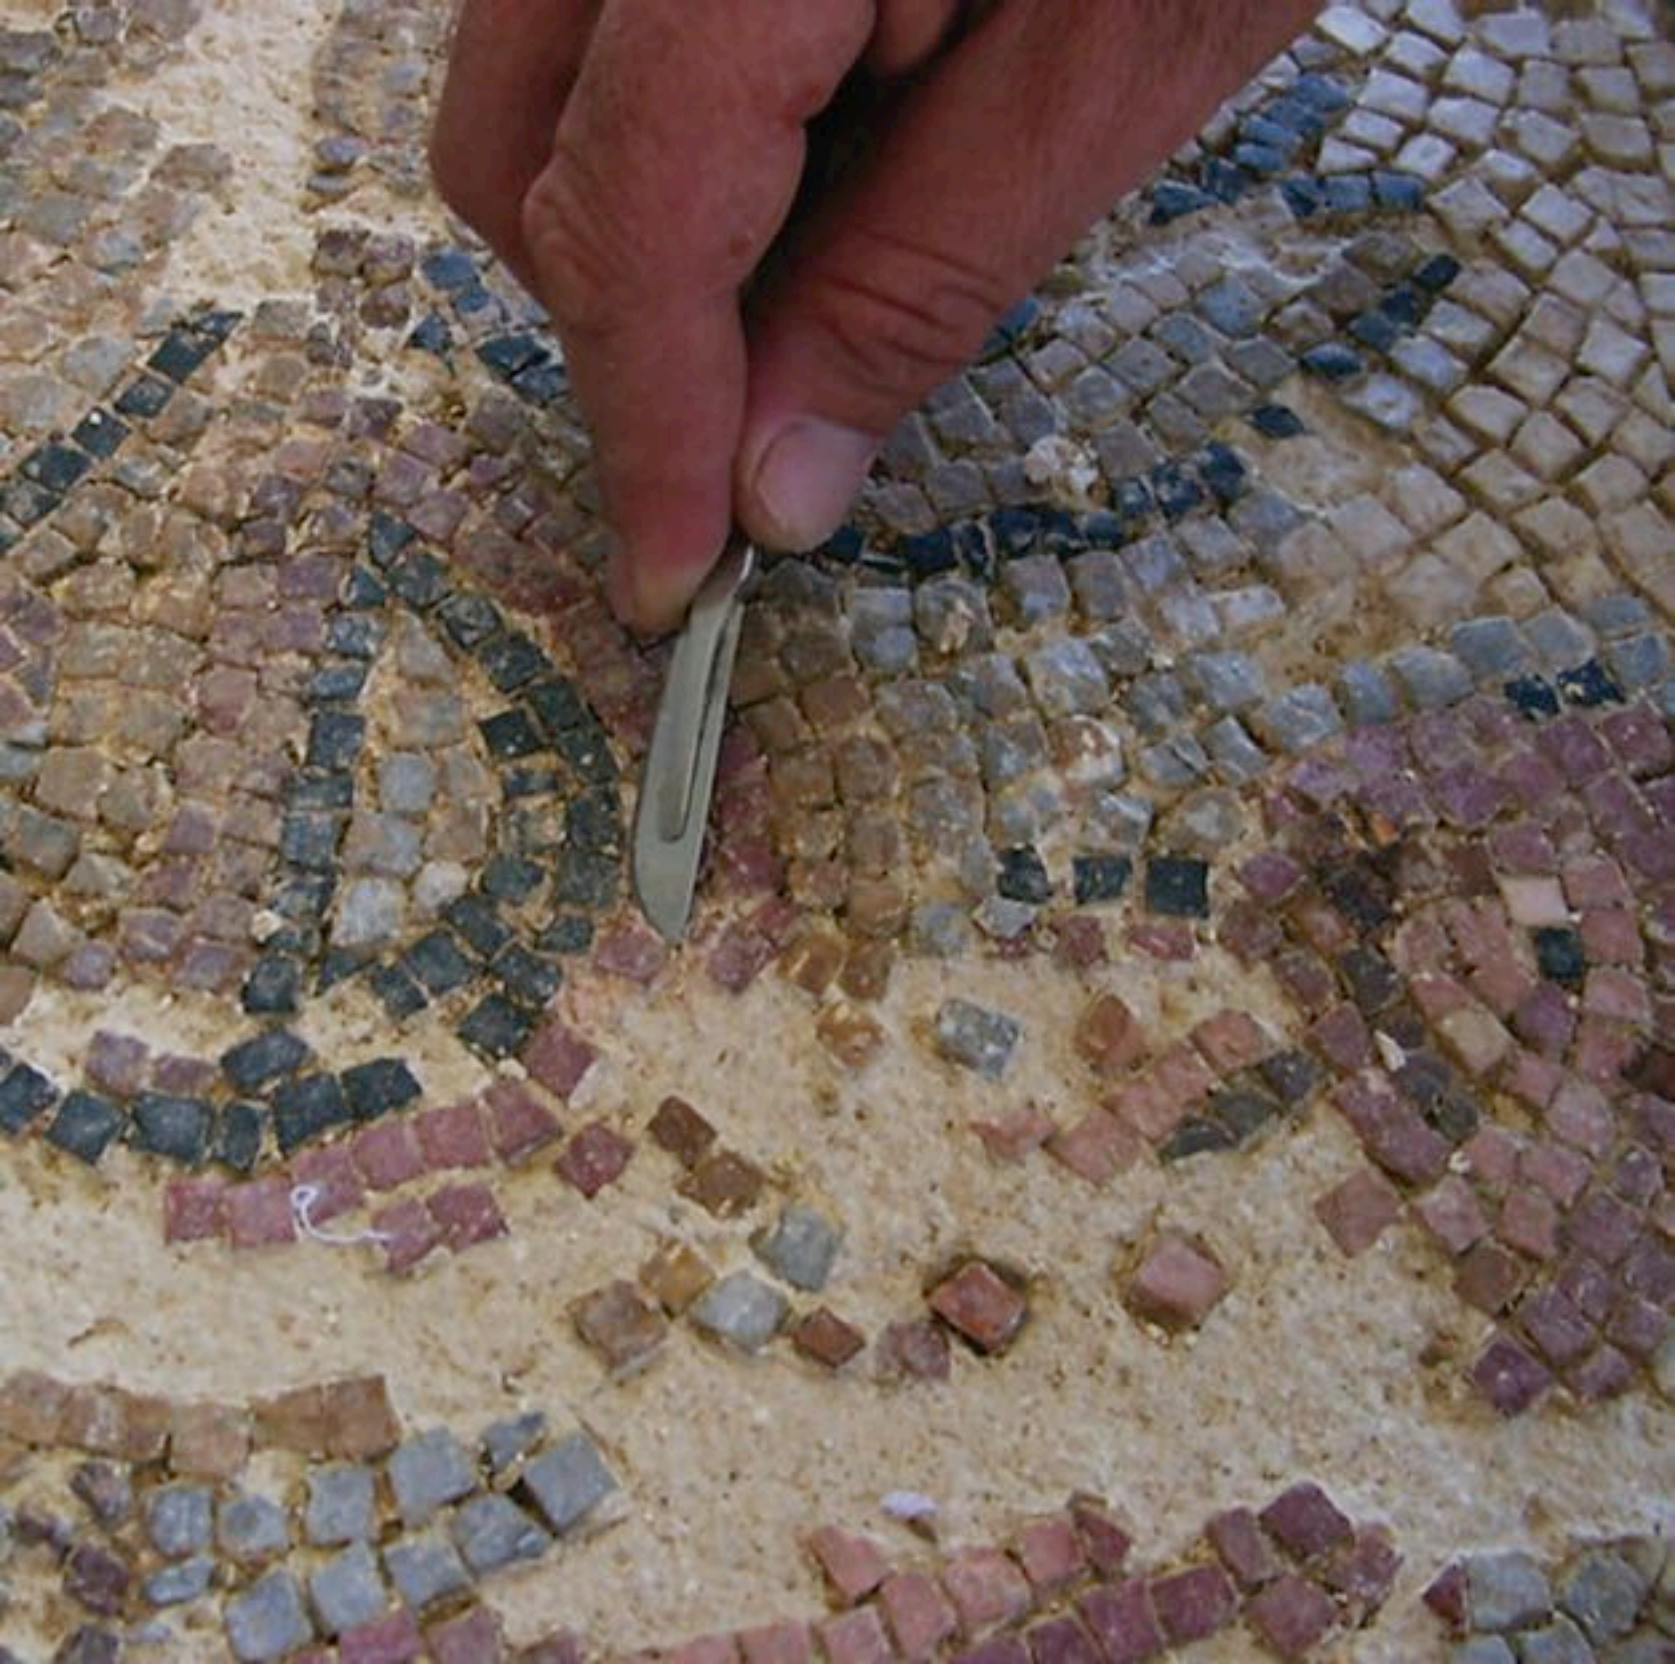
During this last phase a special attention was put on the mosaic of the apse of the church, which were stored, over a concrete bed, into the Memorial of Moses on Mount Nebo.

The old cement support was removed and mosaics were restored and relaid over a new compatible bed.

Only reversible materials and techniques have been used, the entire process of intervention is identifiable and has been documented.

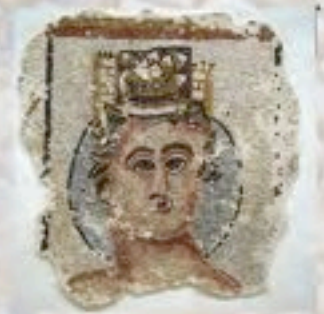
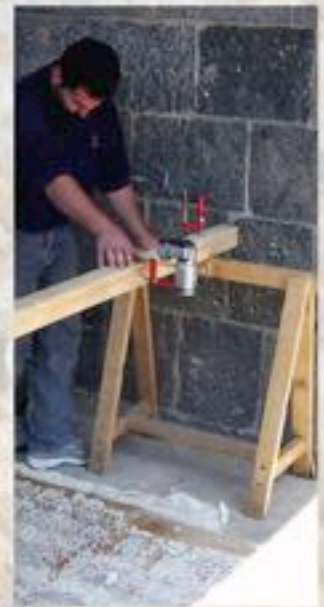
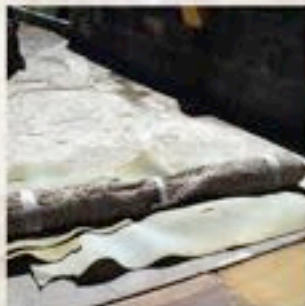
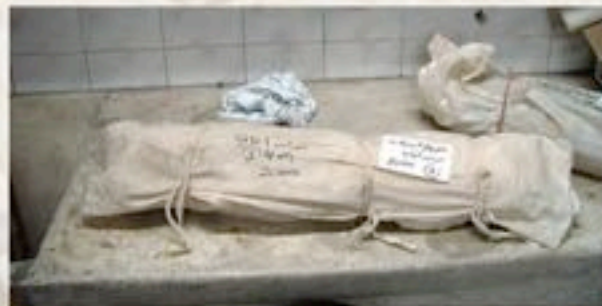
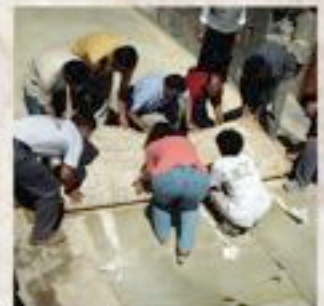
Partly stolen and rescued by the authorities, the mosaics were in a very poor condition. They had been stored in Damascus, in the Department of Antiquities, in less than ideal condition.

In fact the Syrian Department of Antiquities, worried for the safety of the mosaics after some parts were stolen, had proceeded to the detachment, gluing a cotton sheet over the mosaics and then enrolling them.

The bad condition of the mosaics influenced the work plan of the training course and special attention was given to save the tesserae which were detached during storage.

1. The rolls were opened and the various pieces of mosaics were photographed to document their state of conservation.
2. Lot of tesserae were no longer glued over the cotton sheet. All the detached tesserae were collected, stored into plastic bags and catalogued following the area of origin.
3. The glue which was used for the detachment was very strong and it was not enough to clean the mosaics with water. To take out all the remains of glue and cotton, trainees had to use chemical products left over the mosaics for ten minutes and then washed by water or ammonium carbonate AB57 diluted by EDTA salts, left over the mosaics for ten minutes and then washed several time with water, to clean all the salts. Then trainees had to clean the surface carefully by water and brush or by chisel.

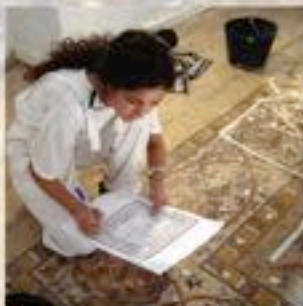
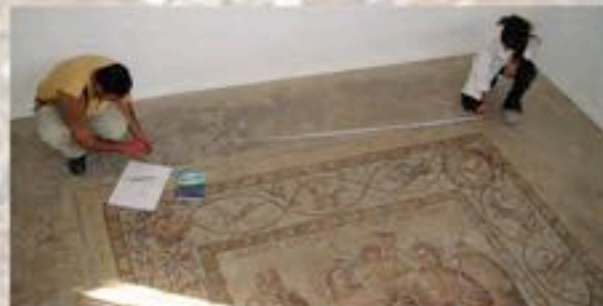
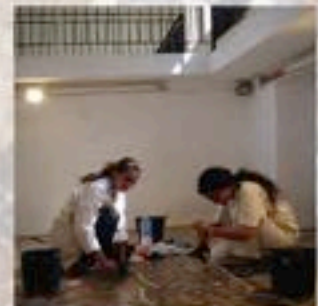
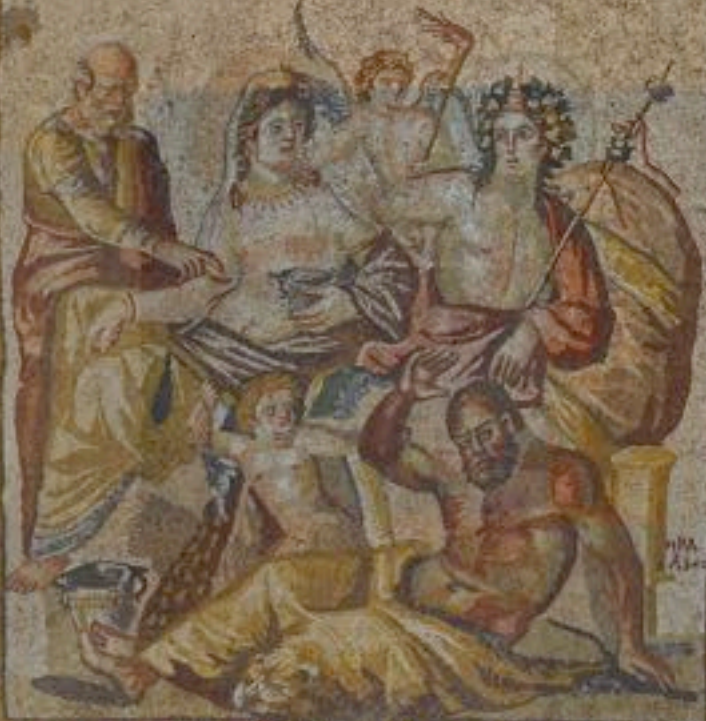
- lacunae filled by black or white cement
- areas which had suffered by fire
- depressions
- residues of lime and varnish, due to lack of attention during the painting and varnishing of the walls and the handrails that surround the mosaics
- detachment of the mosaic from its original bed
- missing tesserae
- black patina, light and dark concretions
- swellings

4. Due to time constraints, the intervention carried out focused on the following:

5. All the actions of cleaning and consolidation have been documented over the sketches.

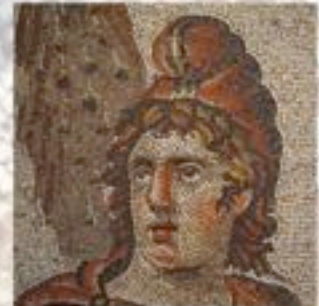
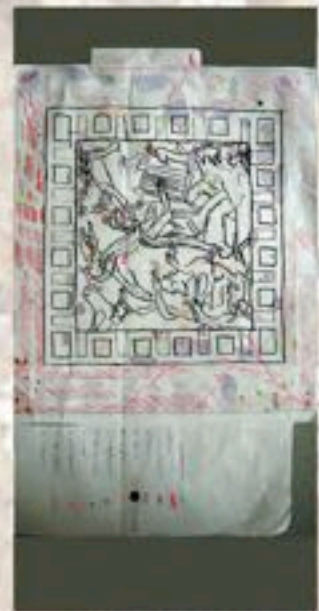
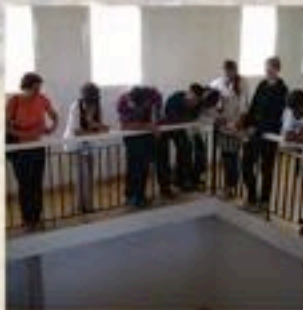
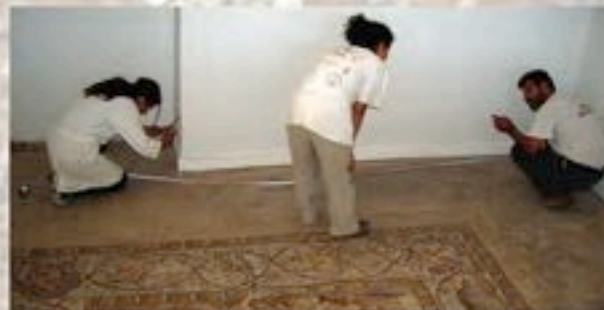
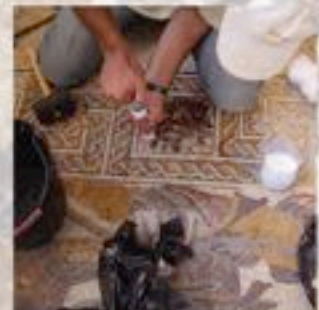
3. The state of conservation of the mosaics has been analyzed and reports of the trainees have underscored that all the mosaics had the same problems:

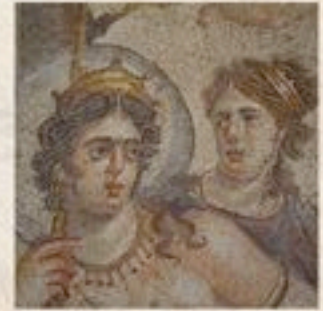
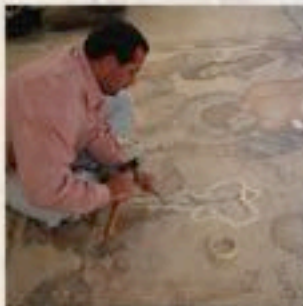
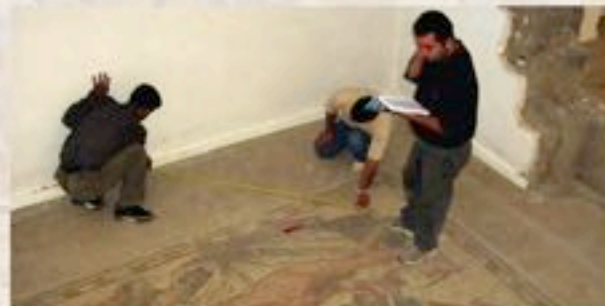
- lacunae caused by detachment and re-laying were filled by black or white cement
- various cracks over the entire surface of the mosaics, caused by errors in the re-laying over cement support
- many tesserae were missing, due to the detachment, and many were fractured
- black patina, light and dark concretions concentrated in the external frame.
- residues of lime and varnish, due to lack of attention during the painting and varnishing of the walls and the handrails that surround the mosaics

In final reports, trainees recommended that the cement supports of the mosaics should be removed and mosaics re-laid over a compatible support, like we did during the training course for the mosaics from Aphamea.

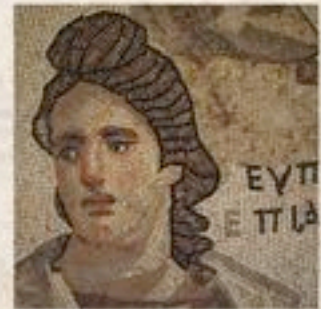
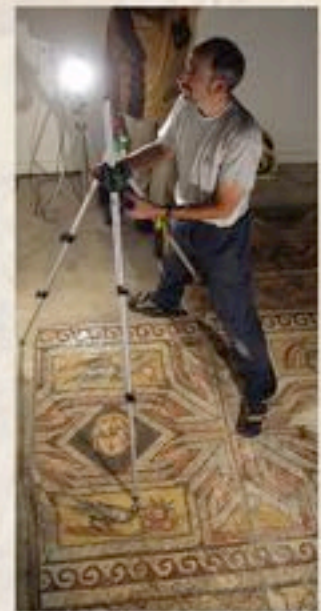
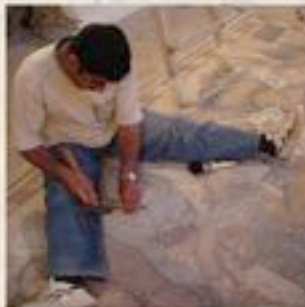
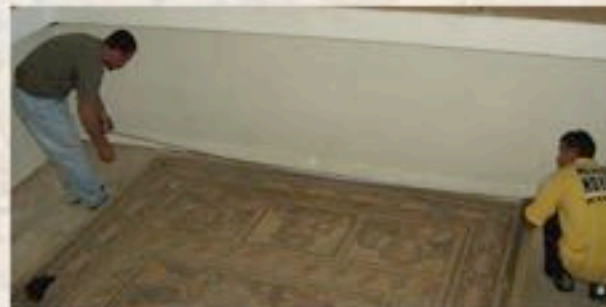
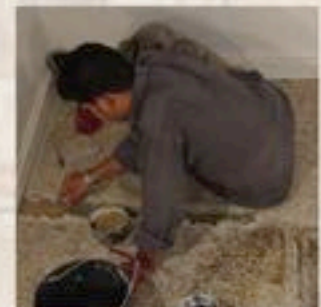
3. Mosaics were detached in the past from their original site, divided into sections following their dimensions and then re-laid over a cement support. Their state of conservation has been analyzed and reports of the trainees have underlined that, comparing with *in situ* mosaics, they were suffering from different problems, among which:

- a. Mechanical cleaning over all the surface of mosaics by plastic brushes, sponges and water.
- b. Lacunae which have been filled in the past by black or white cement were removed and the void were filled by new compatible mortar.
- c. Consolidation work was carried out around the borders of the lacunae by compatible mortar strips.
