**BILAD AL-SHAM II - TRAINING COURSE IN
MOSAIC RESTORATION**

Madaba - JORDAN - Suwaydah - SYRIA - Jericho - PALESTINE

Edited by Osama Hamdan - Carla Benelli

Bilad Al Sham II – Training Course in ancient mosaics restoration

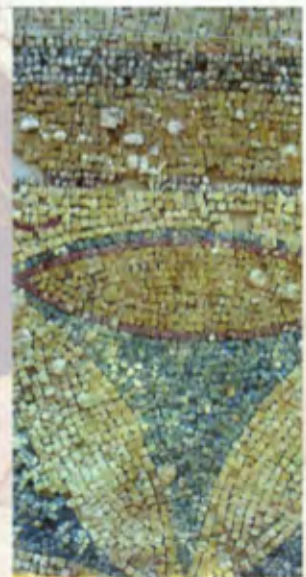
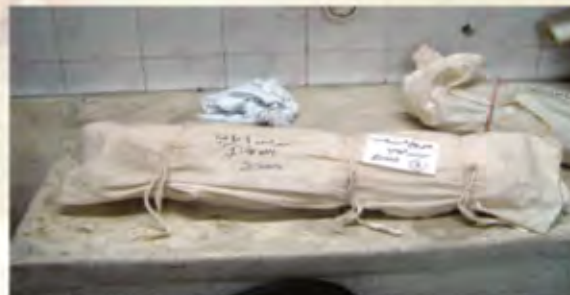
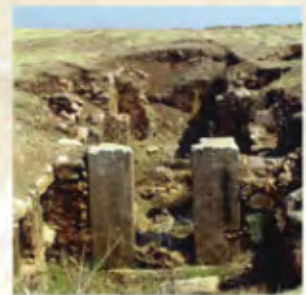
Partly stolen and rescued by Syrian authorities, the mosaics were in a very poor condition. They had been stored in Damascus, in the General Department of Antiquities and Museums, in less than ideal condition.

To start the conservation activities of the training course, the mosaics were transported from Damascus to the Shahba Museum. For the trainees it was a very good opportunity to work on mosaics in such bad condition. They could work on mosaics detached from their original site and not re-laid over a solid bedding layer.

In fact the Syrian General Department of Antiquities and Museums, worried for the safeguard of the mosaics after some parts were stolen from the tomb, had proceeded to the detachment, gluing a cotton canvas over the mosaics and then enrolling them.

The bad condition of the mosaics influenced the work plan of the training course and special attention was given to save the tesserae that came off during storage.

Restoration activities carried out during the first training course in 2003 can be summarized as follows. After the documentation on the state of conservation, mosaics were mechanically and chemically cleaned over the surface and residues of mortar and sand were taken off from the back.

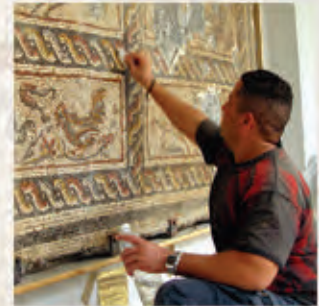
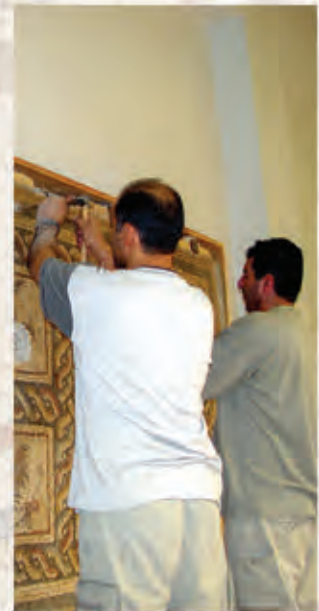
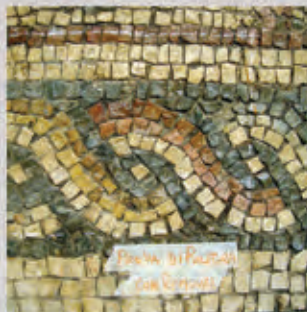
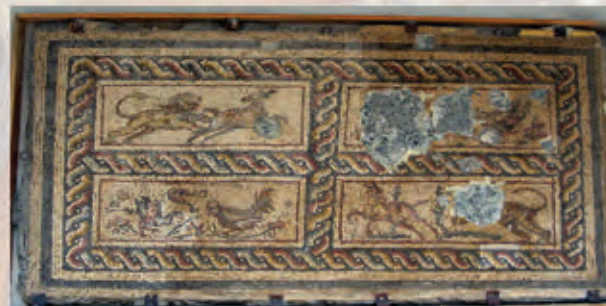
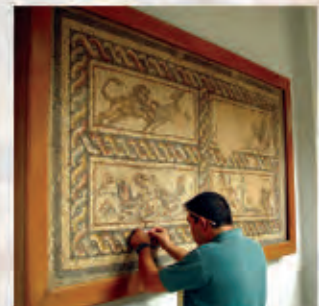
In the past the mosaic has been detached, laid over a cement bedding layer and exposed in the Museum. The panel showed a serious of problems, among which:

- the hardness of the bedding, composed by cement mixed with basalt;

- a protective varnish applied over the mosaic surface, without cleaning it before the application, which accelerate the degrade;
- residues of cement due to lack of cleaning after the re-laying process;
- an excessive weight due to the thickness of the cement bedding layer;
- internal lacunae restored in the past by cement mortar;
- some tesserae were disaggregated and exfoliated.

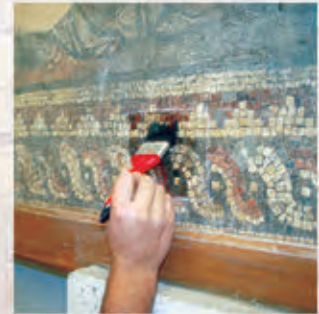
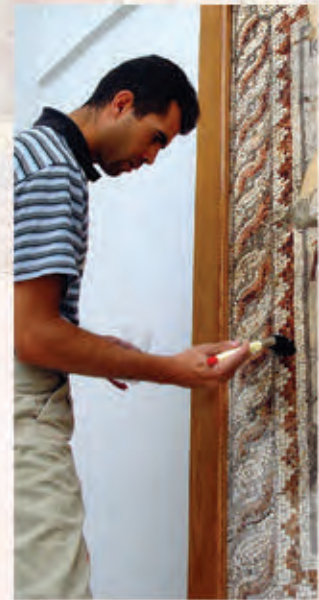
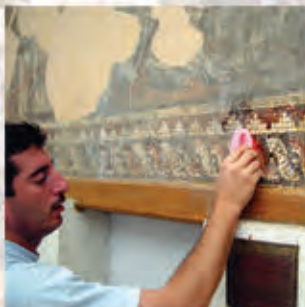
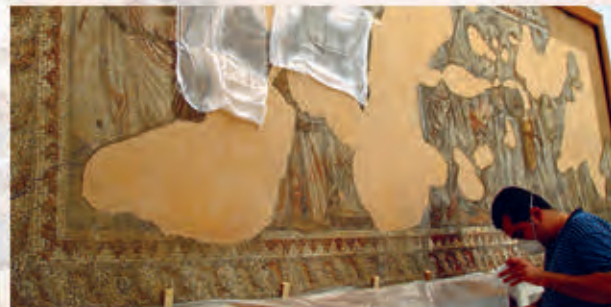
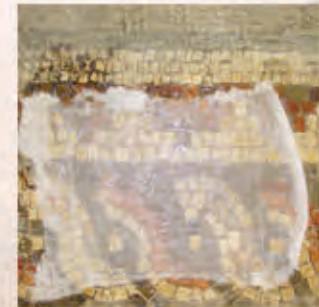
The panel showed a series of problems, among which:

- Chromatic alteration by fire damage;
- A cement deposit on the mosaic surface;

- Presence of incompatible materials with the principles of conservation, used to glue together the pieces of mosaic;
- Lack of many tesserae;
- The hardness of the bedding layer, composed by cement mixed with basalt.

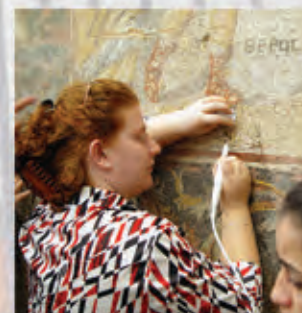
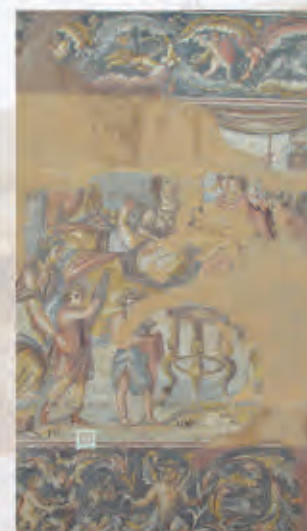
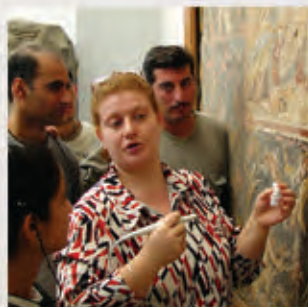
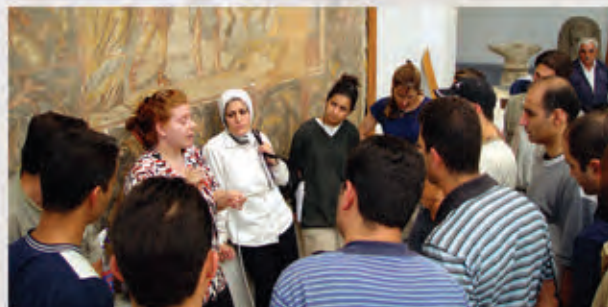
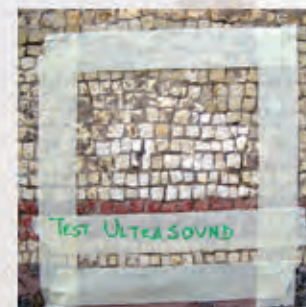
A special section of the training course concerned various methods and tools to clean mosaics by mechanical way. Two days of the training course were spent to show and explain structure and function of different tools, how they should be used in the cleaning process and different aspects to take into consideration before to choose the most suitable cleaning method.

Tests were carried out to teach trainees the best use of each tool, to check their efficacy and to monitor positive and negative results.

Small parts of mosaic surfaces – not more than 10 x 10 cm. – were chosen for tests.

In the Shahba mosaic, the test was conducted on the external lateral surface, because it was far from the main decoration and also because marginal parts of the mosaic were suffering more problems than the central part. If the cleaning test would have given good results in the most difficult area, it will be successful also on the remaining surface.

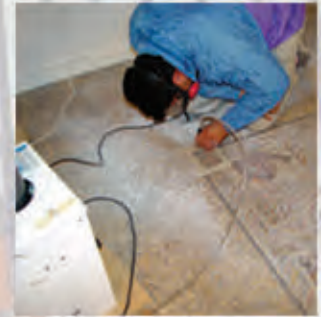
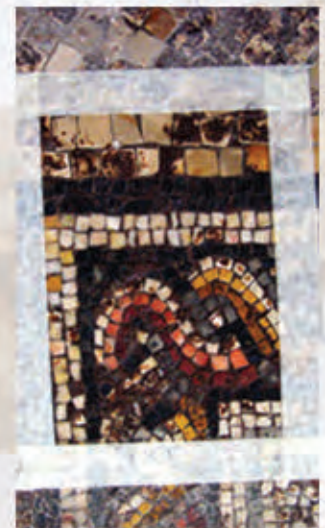
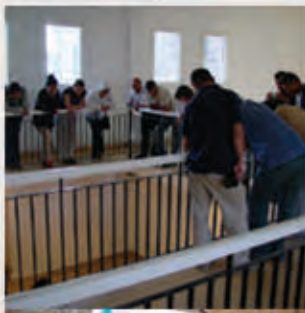
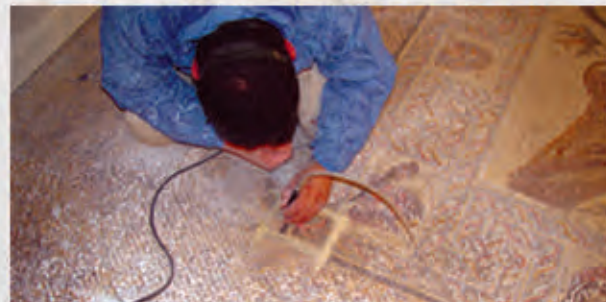
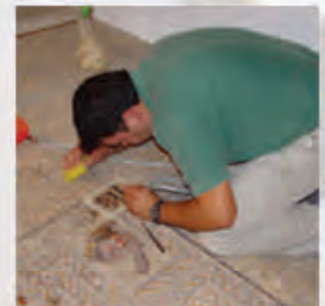
- Micro Sand blaster machine: it is a tool that works spraying aluminum oxide. The test was carried out by the Italian restorer Mr. Franco Sciorilli, over the mosaic of *Orpheus and the animals*, which decorates the pavement of the Roman villa preserved inside the Shahba Museum (Syria). A small part of the mosaic was chosen to carry out the test in a very careful way, also to teach how to carry out tests in a safety way wearing protective mask and glasses.

The result of the test was good, and among the positive aspects of this instrument, there is the possibility to control and remove easily the residues of dirty without damaging the mosaic.

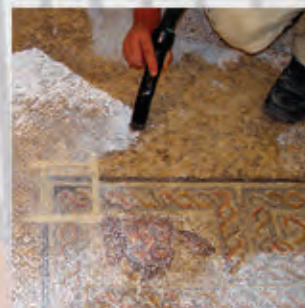
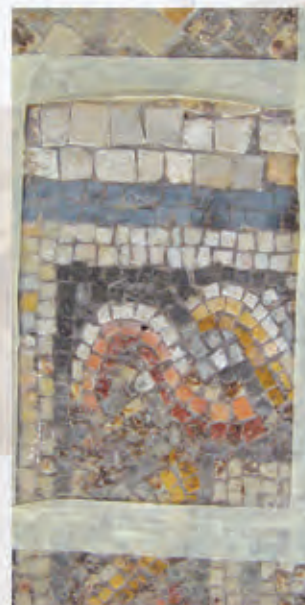
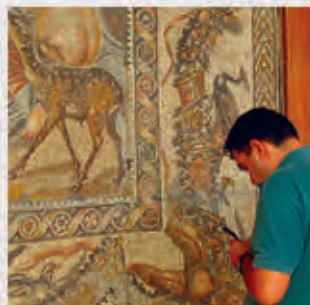
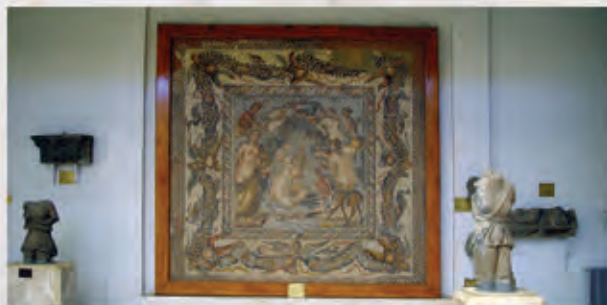
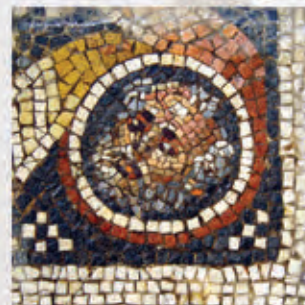
- Vibrating cutter: it is a small tool that works through air pressure and water. The pressure of the air can be controlled by the restored, following the hardness of the stones and of the crusts and concretions to remove. The result of the test was good.

In general, all tests gave good results and the experimented tools can be considered all suitable for mosaic careful cleaning. Anyhow it should be taken into consideration that all the mechanical tools left few scratches over the mosaic surface and removed part of the protective patina.

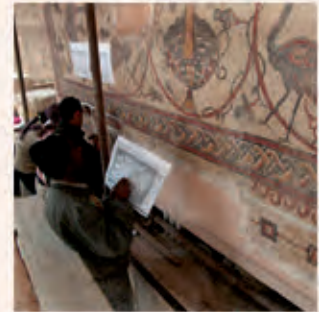
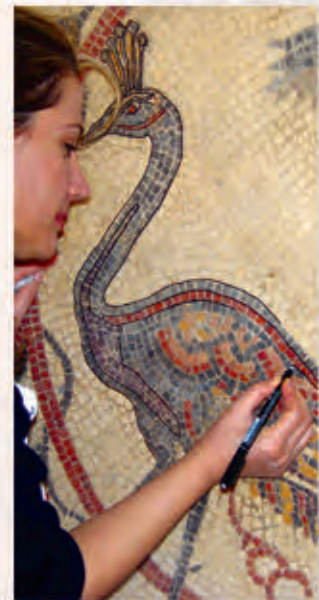
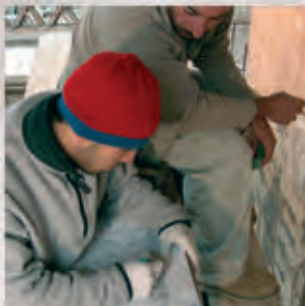
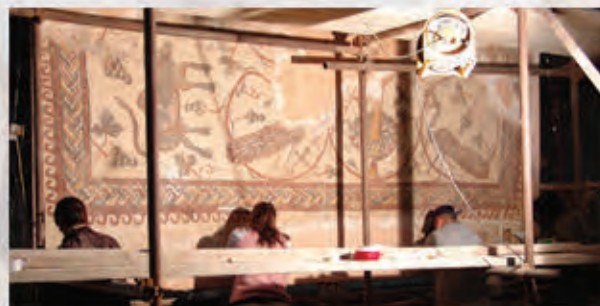
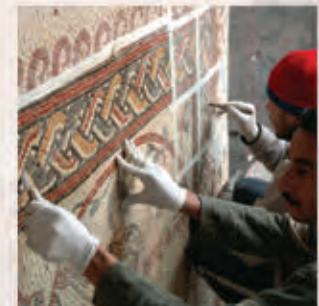
The team worked to remove the cement layer and to re-lay the pieces of mosaic over honeycomb panels. The original design of the mosaic floor of the church was drawn over a plastic sheet, following old photographic and graphic documentation and then the various mosaic pieces were fixed together as in the original drawing, by compatible material. Lost areas of the design were drawn by watercolors.

Due to the lack of documentation and exact plans, some problems emerged in fixing all the pieces. So the team went back to the original site, from where the pieces were detached in 1977, to document the plan of the church and to study if it was possible to put back the mosaics or to exhibit them in another compatible site.

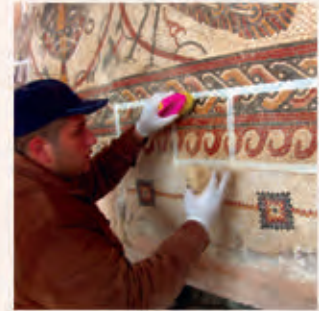
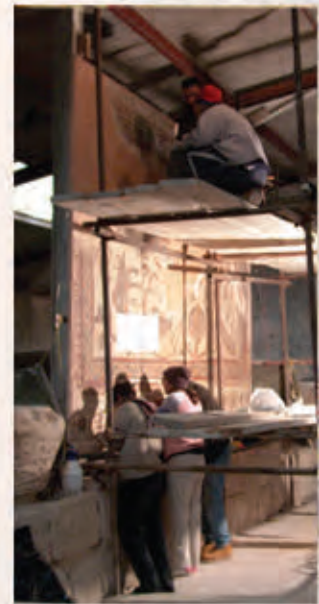
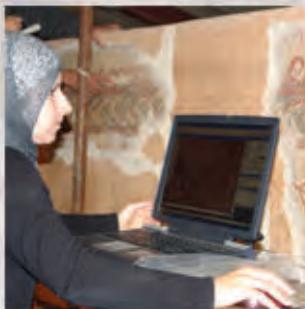
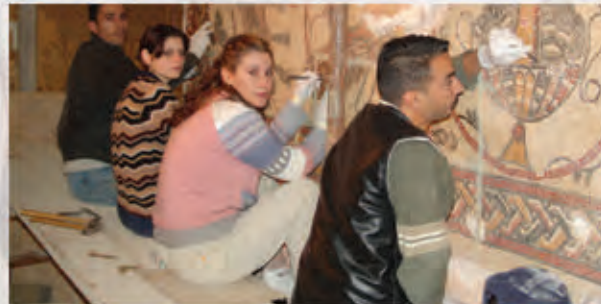
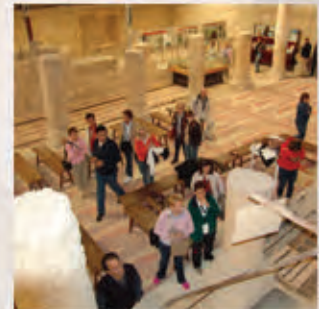
This year we worked over the northern nave panel. It is a rectangular panel, 4,32 x 2,95 m, decorated with vine scrolls formed by two vines emerging with a palm from a jar placed between two peacocks.

The scrolls contain the figures of a vintner cutting grapes and a young man portrayed as an orans: John [son] of Ammonius. Inside the eastern side of the panel, but not in the scrolls, a lion and a zebu face each other.

- Residues of black cement over the mosaic surface;
- Lacunae closed in the past by black cement;
- Depression;
- Decay of tesserae;
- Cracks;
- A layer of wax over the entire surface.

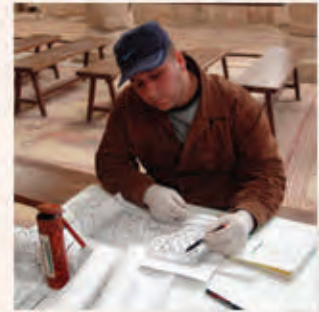
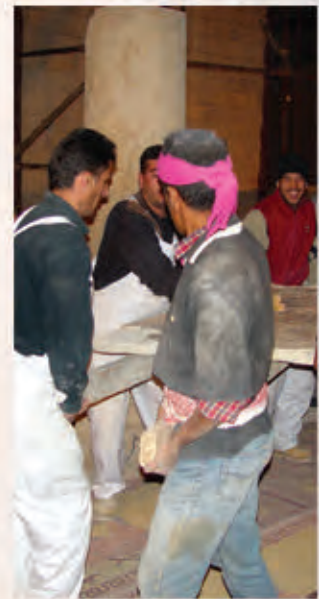
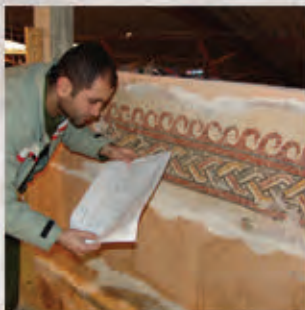
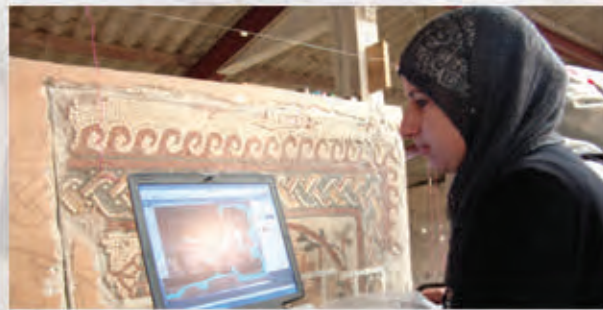
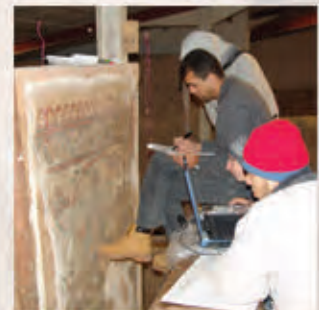
The panel was in bad condition, in particular for the following problems:

The mosaic was standing in vertical along the central nave of the Moses Memorial Church at Mount Nebo, fixed on its roof. Working on a scaffold, trainees carried out the following restoration works:

- Documentation of the state of conservation of the panel, before any intervention.

The work was carried out where the mosaic was in exhibition, inside the church. Due to the importance of this phase during this year training course, the activity will be described in a dedicated chapter.

- Residues of cement and mortar over the surface were removed using scalpel, hammer and chisel.

- The superficial layer of wax was chemically removed using cleaning packs of trichloroethylene, a chemical product used to remove oily materials. Due to the location of the mosaic, this activity was particularly complex to be carried out.

- It was necessary to remove the wax from the surface of the mosaic, to fix a cotton canvas to remove its concrete bedding-layer.

- The panel was drawn over a nylon sheet at scale 1:1, using various colors: black to draw main lines; red to define lacunae; blue for cracks; green for external lines; light blue to define the lines where to cut the mosaic for the removal of the bedding. Over the surface of the mosaic, a series of points of reference were drawn, to facilitate the reassembling of the sections after the restoration.

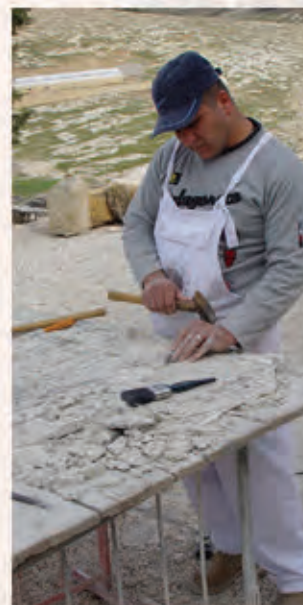
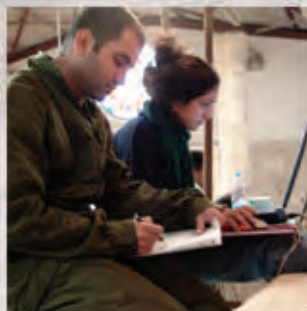
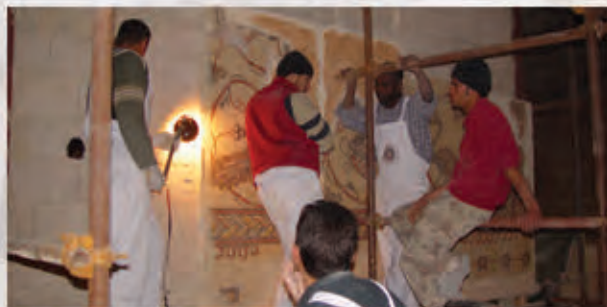
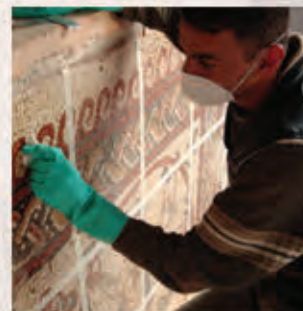
- Due to its heavy weight, to remove the panel from the church, trainees had to cut it into sections. When they started the work, they discovered that the cutting would have been very difficult and slow because there were iron bars inside the concrete of the bedding-layer.

- The panel was finally taken out of the church in seven sections. To avoid the lost of tesserae during the removal of the bedding, the sections were fixed by a cotton canvas, glued over the surface by vinyl adhesive left for 24 hour and then with another cotton canvas fixed by animal glue.

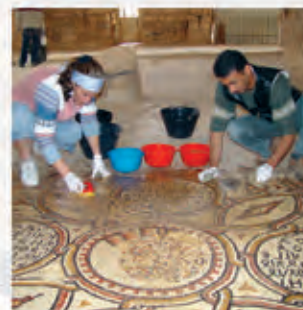
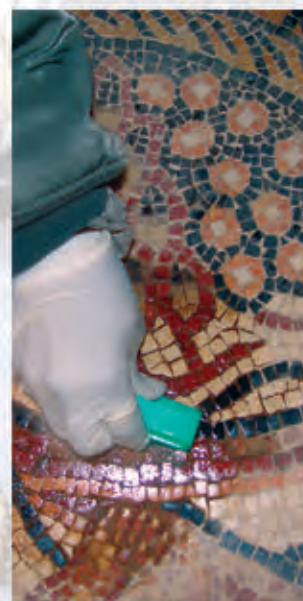
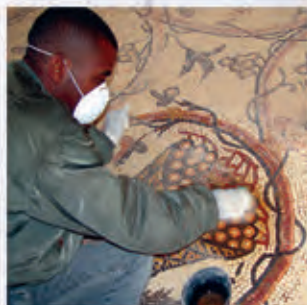
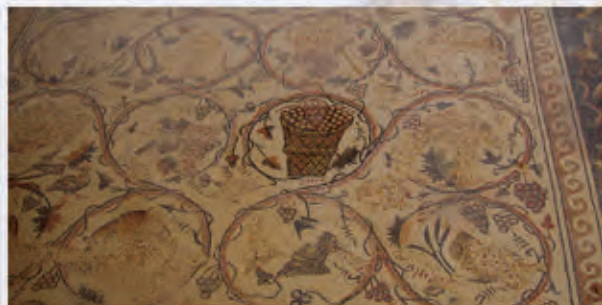
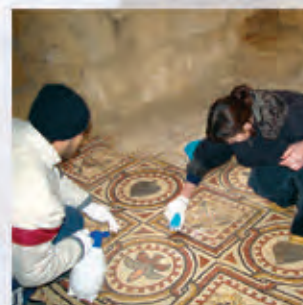
The intervention during the training mostly focused over the cleaning of the mosaic pavement by broom and brushes from dust and sand collapsed from the walls. During the survey on the state of conservation of the mosaic, we noticed an oily layer over some parts of the surface. From a quick inquiry emerged that the guardian of the site, following a personal initiative, used to oil the surface of the mosaic to show it shining to visitors, who could take nicer pictures. So this layer had to be removed by thinner, brushes and cotton. The guardian was informed over the negative impact of his habit on the mosaic.

The cleaning was carried out after having reinforced the mosaic by fixing some loose tesserae by mortar based on lime, stone powder and local sand (from Suwaylah) at 1:1:1,5. To avoid the lost of further tesserae, lacunae were filled by mortar based on lime, stone powder and local sand at 1:1:1.

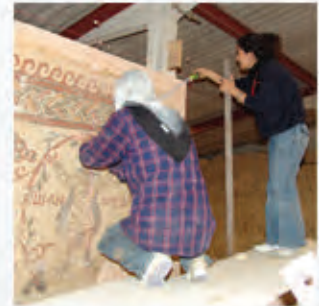
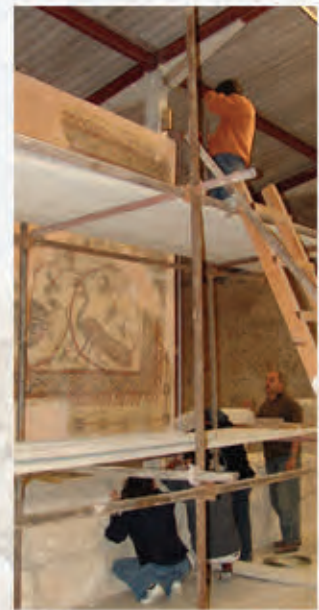
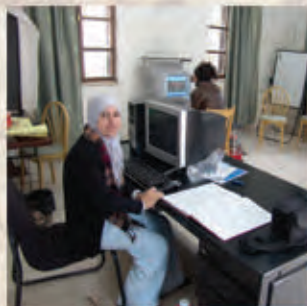
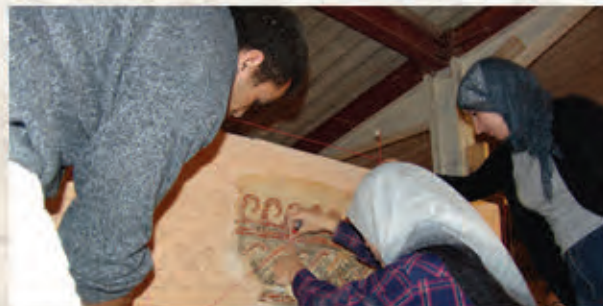
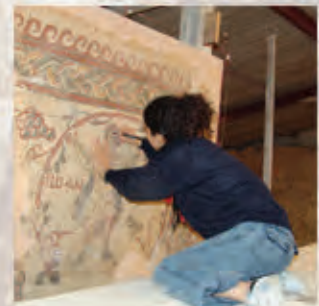
One of the most common ways to prepare the documentation of mosaic floors uses digital camera to take pictures and computer to transfer and process data. This method allows getting very accurate information at true scale and high resolution images.

We used this process to document the mosaic of the Church of Saint George, during Bilad Al- Sham II training course on mosaic restoration, which was held in Syria, Jordan and Palestine.

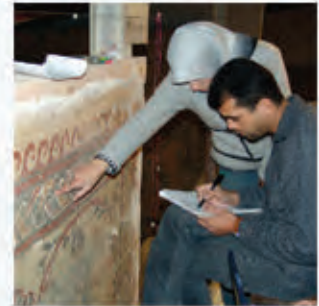
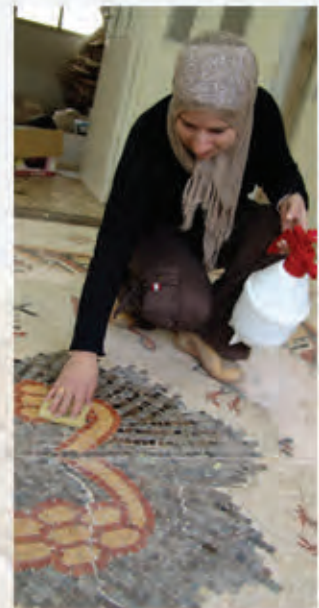
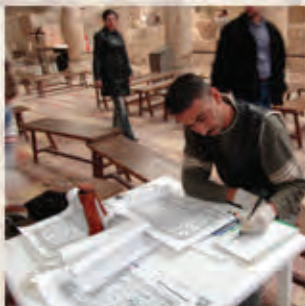
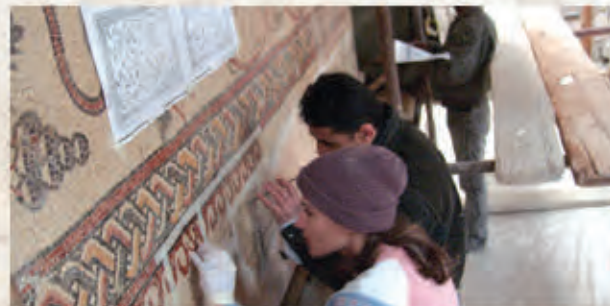
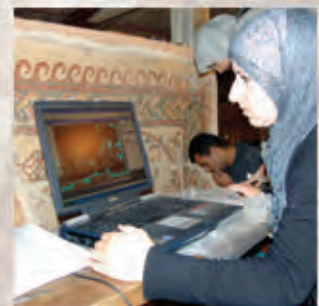
The training section was divided in two main parts:

- 1- Work in the field, preparing works and taking digital photographs;
- 2- Laboratory work, processing the data on computers to have a clear and precise photograph, which reflected the original in its state of conservation. The elaboration of this photograph by computer was at scale, so to have an image to start drawing the mosaic tessera by tessera.

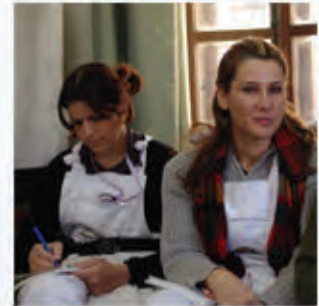
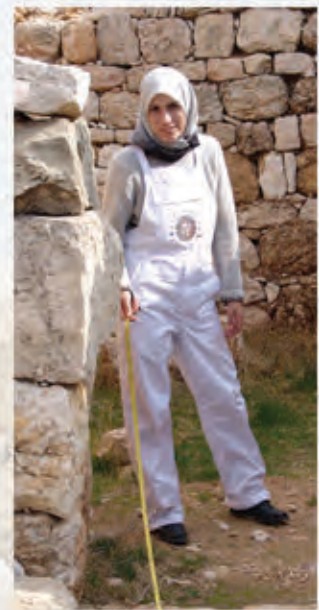
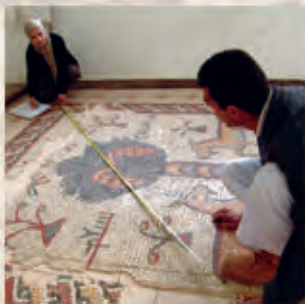
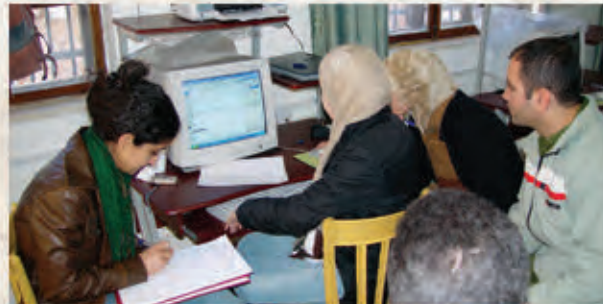
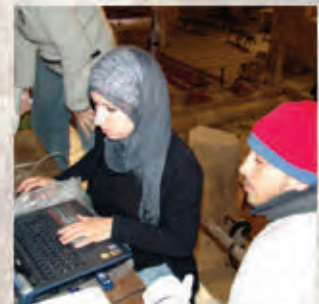
- The general condition of the mosaic floor was studied and analyzed. It was included into a geometric space with a right angle, using a strong plastic string;
- The space was divided on the mosaic into a geometric grid;
- The four corners and the center of each grid space were signed perpendicularly on the surface of the mosaic using a stickers tape. Then the strings were removed;
- A sketch for the grid was drawn on paper after taking all the dimensions of the sides and diagonals of the grid spaces;

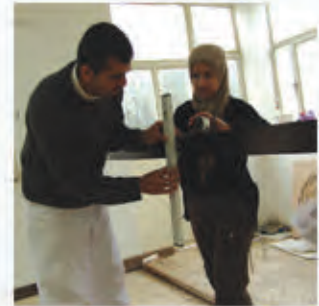
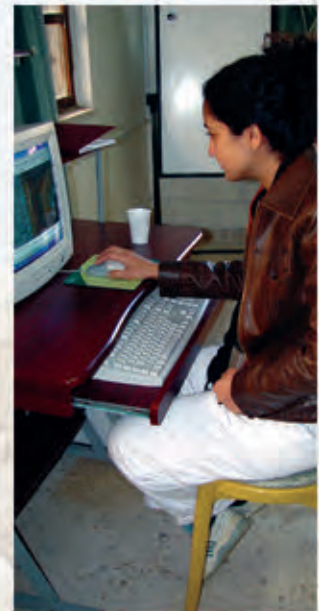
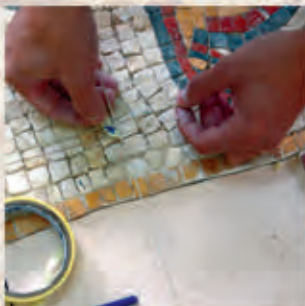
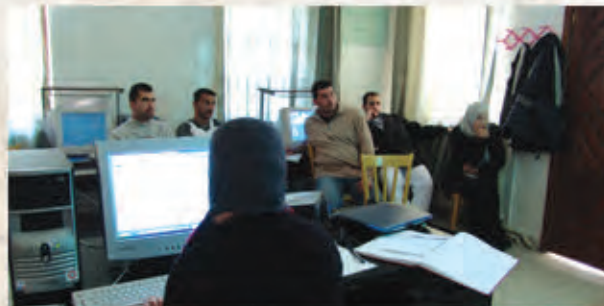
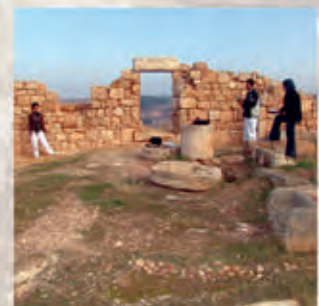
- The grid was drawn on AutoCAD software program, at true dimensions and scale.

- The grid was transferred from AutoCAD to Photoshop software program, to insert all the photos of the mosaic on it. Every photo was fixed on the grid, taking care of its scale and rotation, to put it exactly in the right position and scale. Finally we get a final single photo for the entire mosaic floor;

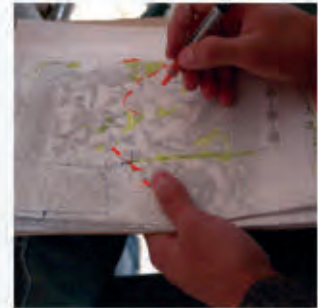
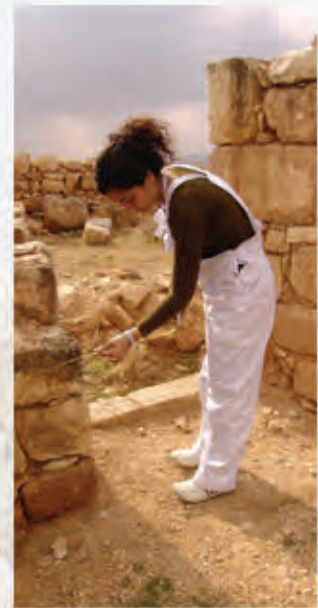
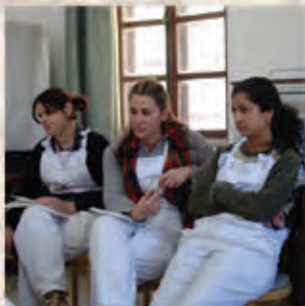
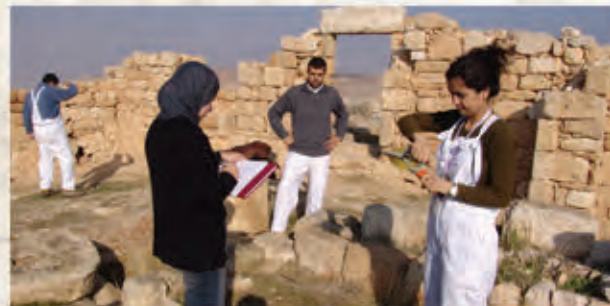
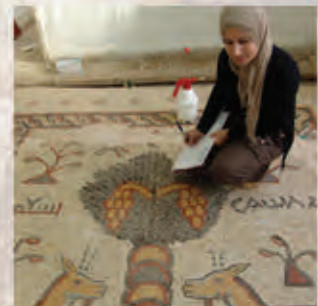
- After the collection of the photos, the final single photo of the entire mosaic was transferred again from Photoshop to AutoCAD, and all the single tesserae composing the mosaic were drawn, to have an exact map of the mosaic;

- This map will be used as a base to prepare, in AutoCAD or Photoshop, the state of conservation map, the intervention map, and other maps necessary to understand the problem of the mosaic and to document exactly which kind of intervention of restoration is done, for each composing part.

At the end, after the analysis of the state of conservation map, the intervention is defined and localized over the base map. In the future, any further analysis or intervention can be based over this documentation.

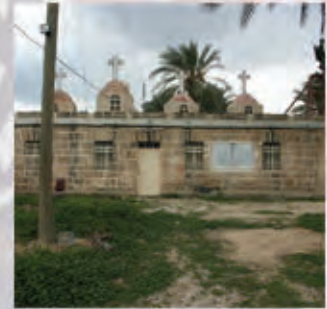
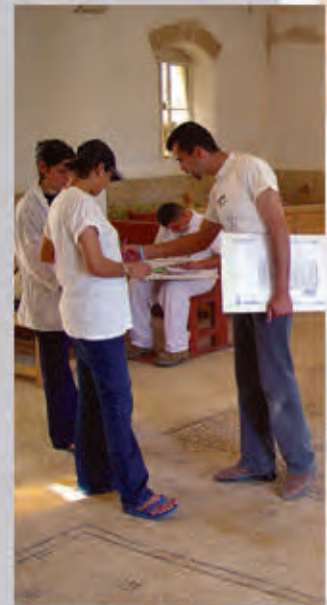
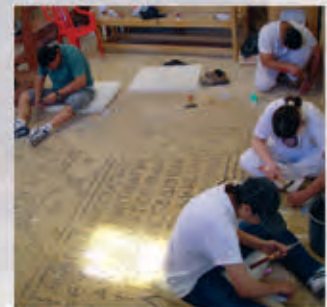
The church of Saint Andrew was built over a necropolis. Inside the chapel, three accesses to the tombs, venerated as relics, have been opened recently. The mosaics of the ancient church belonged to the same nave, probably the only one. The decoration of the two main panels is simple and geometric, composed by white, black and few red tesserae. A mosaic tomb inscription dates the entire mosaic at 592 A.D.

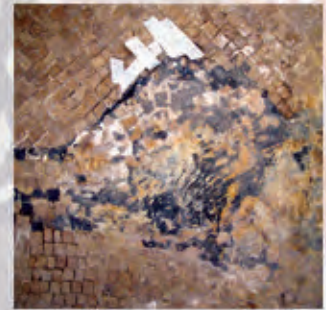
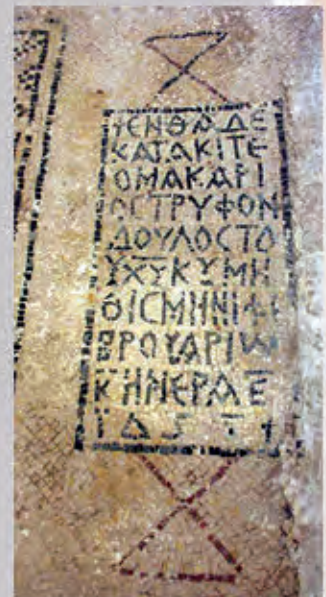
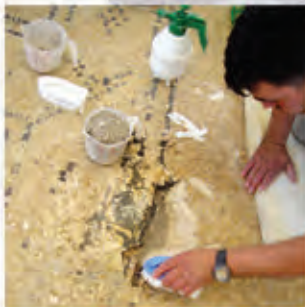
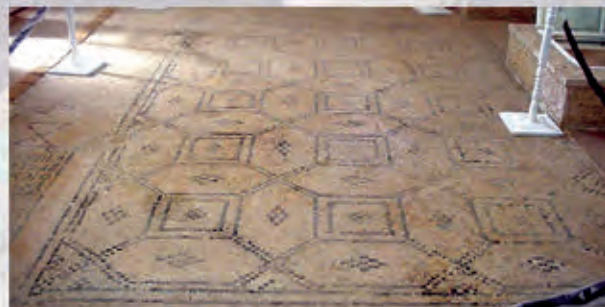
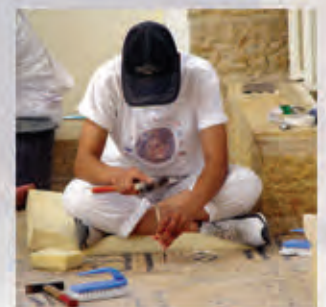
- The mosaic pavement is inside the church, covered and protected by the new building from weather condition;
- Previous restorations, carried out without scientific approach and by material which was not compatible to conservation, had negative impact over the mosaic;
- A diffuse layer of white cement covered the mosaic surface. White cement was used in the past to fill spaces among tesserae and not cleaned after the use;
- A layer of wax, very thick in some parts, was covering the entire surface of the mosaic. It was used in the past with the aim of protecting it and make it brighter;
- There were residues of black cement, used in the past to fix some tesserae;

- The southern part of the church was repaved using cement, until the edges of the ancient mosaic. This caused a condition of rigidity which prevents the natural movement of the mosaic and has as consequences swellings and bulges;

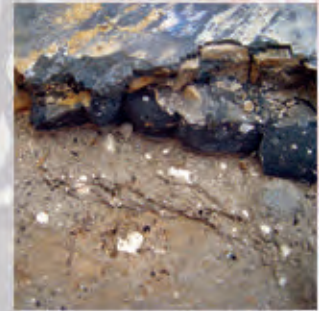
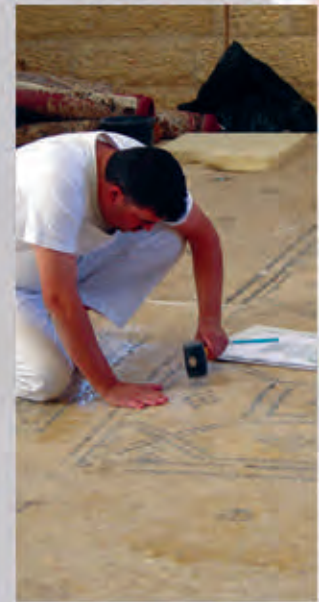
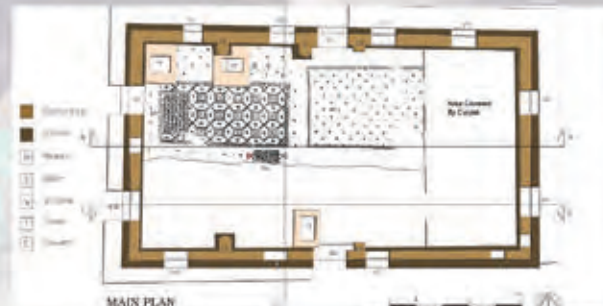
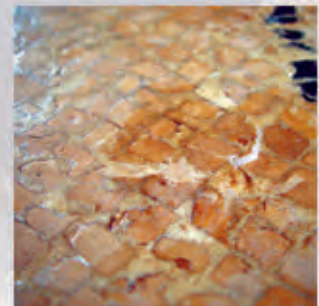
- Someone have used a grinder or other cutting equipment in the site without taking care of the mosaic, and left scratches over the surface;
- Some tesserae, especially the black one, were affected by decay and pitting because of their composition;

- Some depressions were due to the general weakness of the original mortar used to lay the mosaic and by the collapse of heavy materials over the surface;
- There were two kind of swellings: big ones where tesserae were completely detached from the bedding layer and small ones, inside the mortar, shaped as cells;
- There were some loose tesserae, detached from the bedding layer.

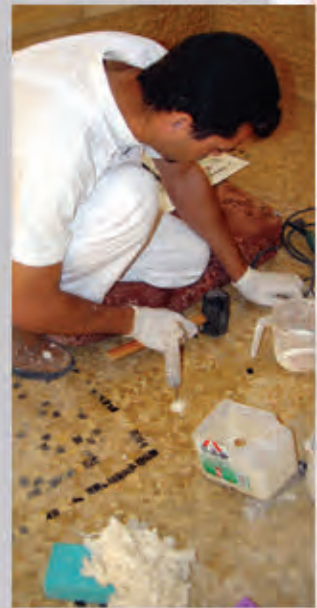
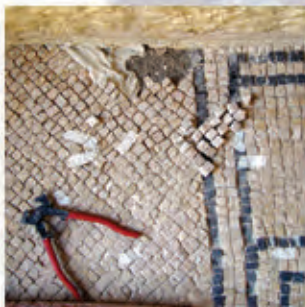
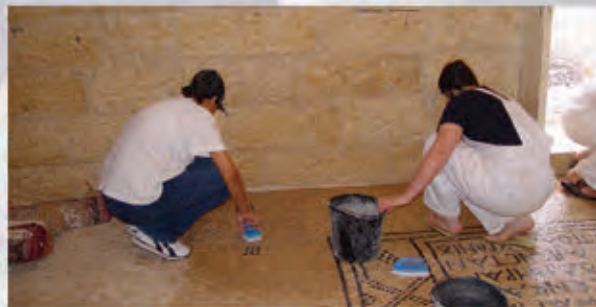
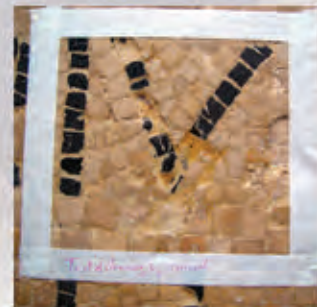
- Trainees made a test to check how to remove the layer of white cement from the surface. They used hammer, chisel and scalpel. Another test was carried out to check how to remove the wax layer both mechanically than chemically, by scalpel and paint remover. The test was positive in both cases;

- The pavement was then divided in squares, to control the different working areas. The mosaic was washed by water, and then the white cement started to be removed in mechanical way by hammer and chisel. This action was very difficult and slow. The cement was hard and the tesserae were weak, so the work had to be done carefully, taking care not to damage the tesserae. Trainees put a lot of time and patience to carry out the intervention, especially in the western part of the mosaic;

- The parts of the mosaic which were restored in the past, by repositioning tesserae in casual way and by black cement, were removed. The original tesserae and the lacunae were completely cleaned from cement and the original bedding layer was consolidated by water and Primal AC33 at 7%;

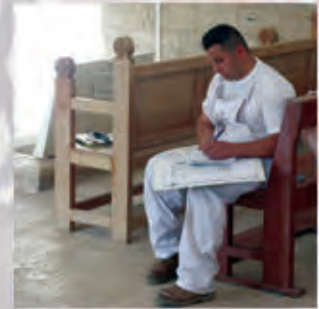
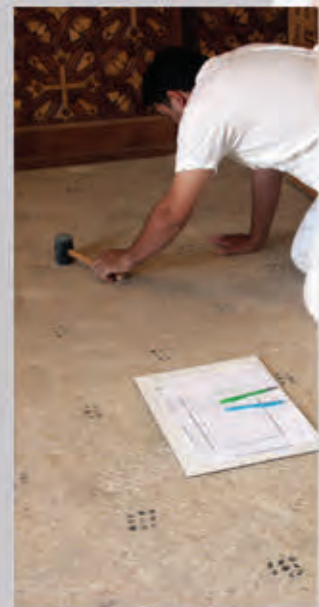
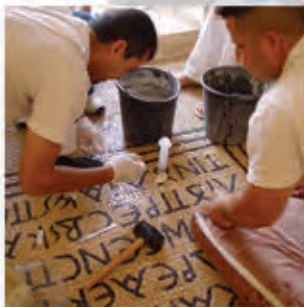
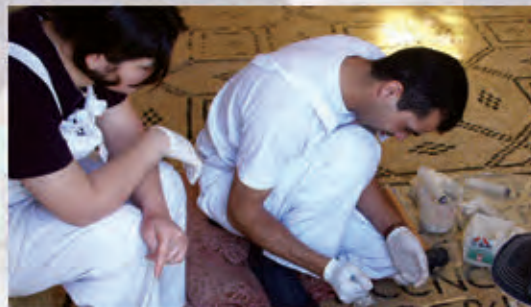
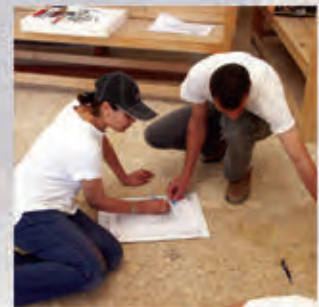
- Consolidation works were carried out over the surface in two ways: the first with water and Primal AC33 and the second adding mortar composed by lime, stone powder and marble powder at 1:1:1. The mortar was liquid and inserted into the mosaic by injection.

To do the injection a small hole was drilled in the pavement (max 3 mm.), at the center of the swelling. The swelling was cleaned by injecting water into the hole to remove all dirt. The swelling was then watered by water and Primal AC33 at 7% and, if it was big enough, liquid mortar was injected inside, to fill it completely;
