# **TRAINING COURSE IN MOSAIC CONSERVATION**

**2006 - 2007**

**Khirbat al-Mukkayat – JORDAN    Hama – SYRIA    Jericho – PALESTINE**

## Mosaics of the Church of St. Andrew (Mar Zaqqa) Jericho – Palestine

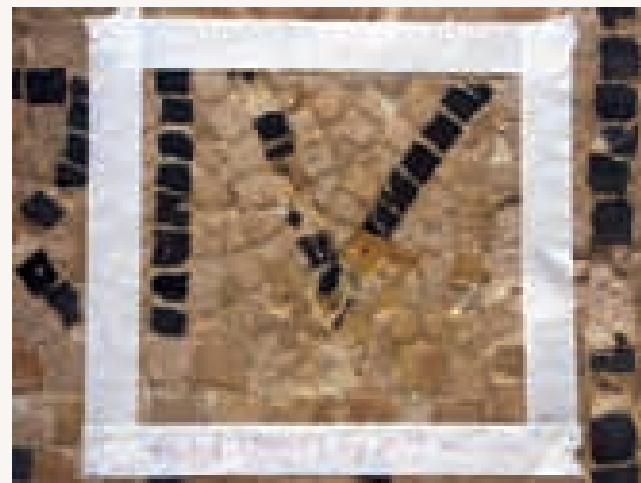
*Cleaning test*

Conservation works started in the western part of the pavement, in the panel near the old entrance. We removed the cement from the surface in mechanical way and the varnish was cleaned up through mechanical and chemical methods.

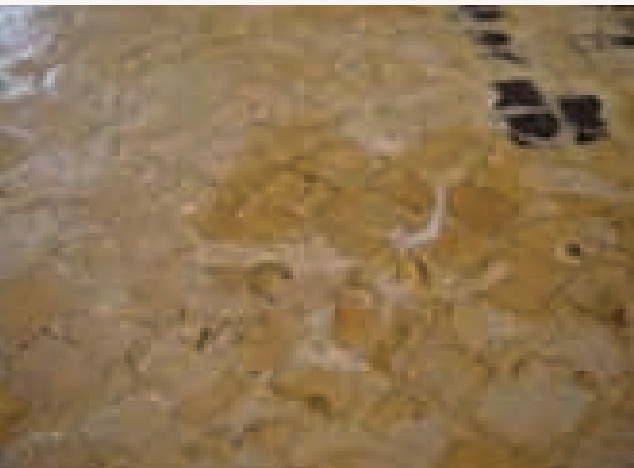
*White cement over the mosaic surface*

- huge quantity of white cement was covering the floor surface. The cement was applied in the past to fill the empty spaces among tesserae and was not cleaned after the use. The layer of white cement was very hard and was one of the most difficult residue to remove;
- the colour of the tesserae was altered by a layer of transparent varnish which was painted over the floor in the past with the aim of protecting it and makes it brighter.
- There were residues of black cement over the tesserae. They derived from the conservation activities carried out in the 1980s to fix some tesserae.
- The cement used to pave the western part of the church

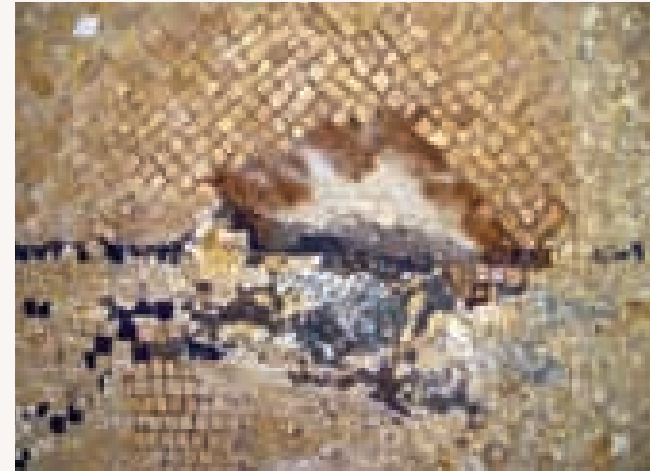
*Black cement intervention*

- The lacunae in the area of the foundations of the dividing walls, near the tomb openings, the iconostasis and the columns of the altars were filled in the past with mosaic tesserae using black cement as bidding material. The action was carried out in improper way and had a negative impact on the aesthetic of the floor.

We worked in the lacunae of the mosaic floor that in the past were repaired with black cement or filled with tesserae in improper way. We removed the incompatible materials (cements or tesserae) after having fixed the edges of the lacunae with scotch-tape or gauze and *Paraloid B72*. New tesserae were then placed to fill the lacunae with lime mortar. To point out the new integrations in the ancient mosaic, we placed the tesserae under level.

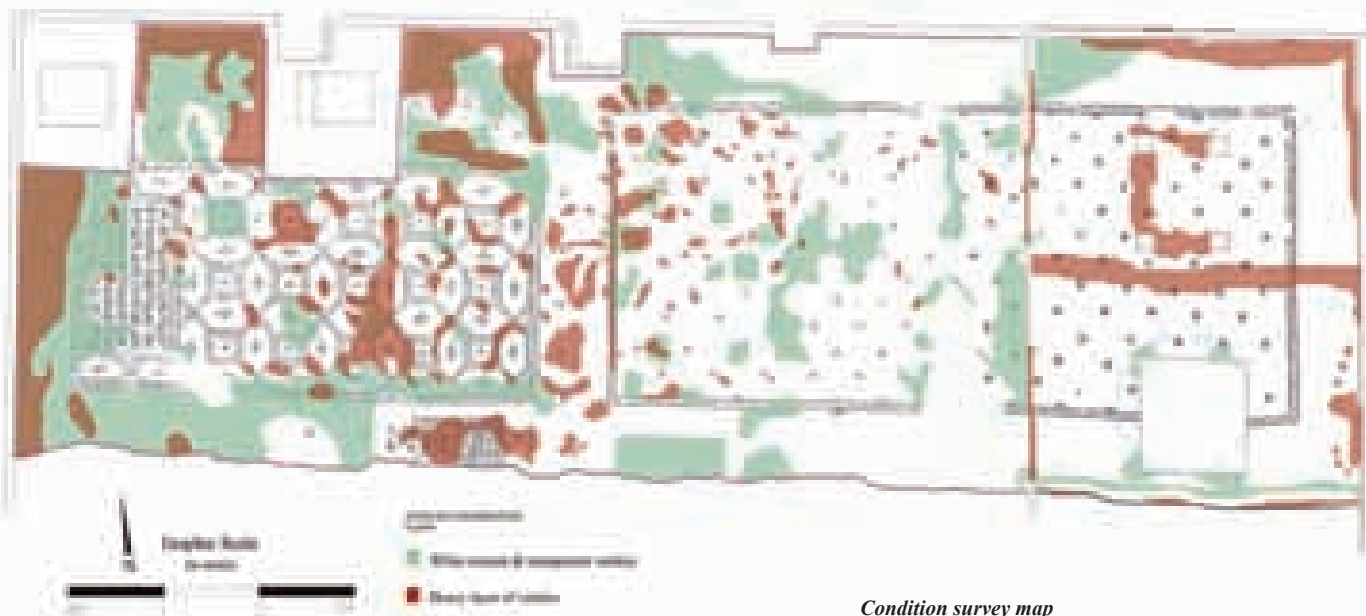
*Condition survey map*

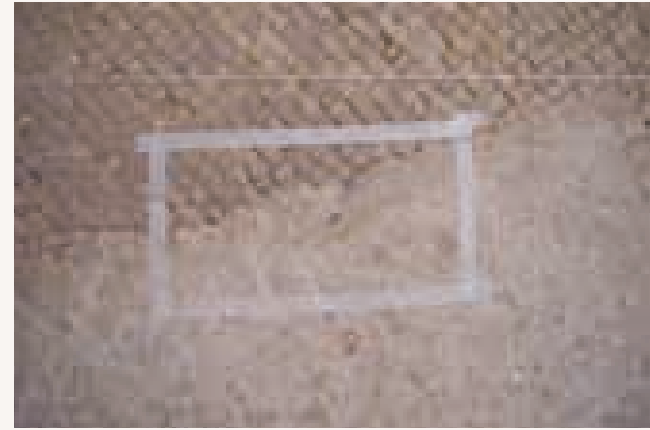
reached the edge of the original mosaic floor. The cement is a stiff material, and a physical barrier. It does not allow the natural adaptation of the mosaic floor and therefore generates swellings in some parts. There are two types of swellings; the first is a vast hole and the tesserae are completely detached from the bedding, while the second is composed by small cavities shaped as cells into the bedding mortar. This event results from the alteration in volume of the different components of the bedding layers caused by humidity or change in temperature.<sup>17</sup>

*Cement pavement near the mosaic floor*

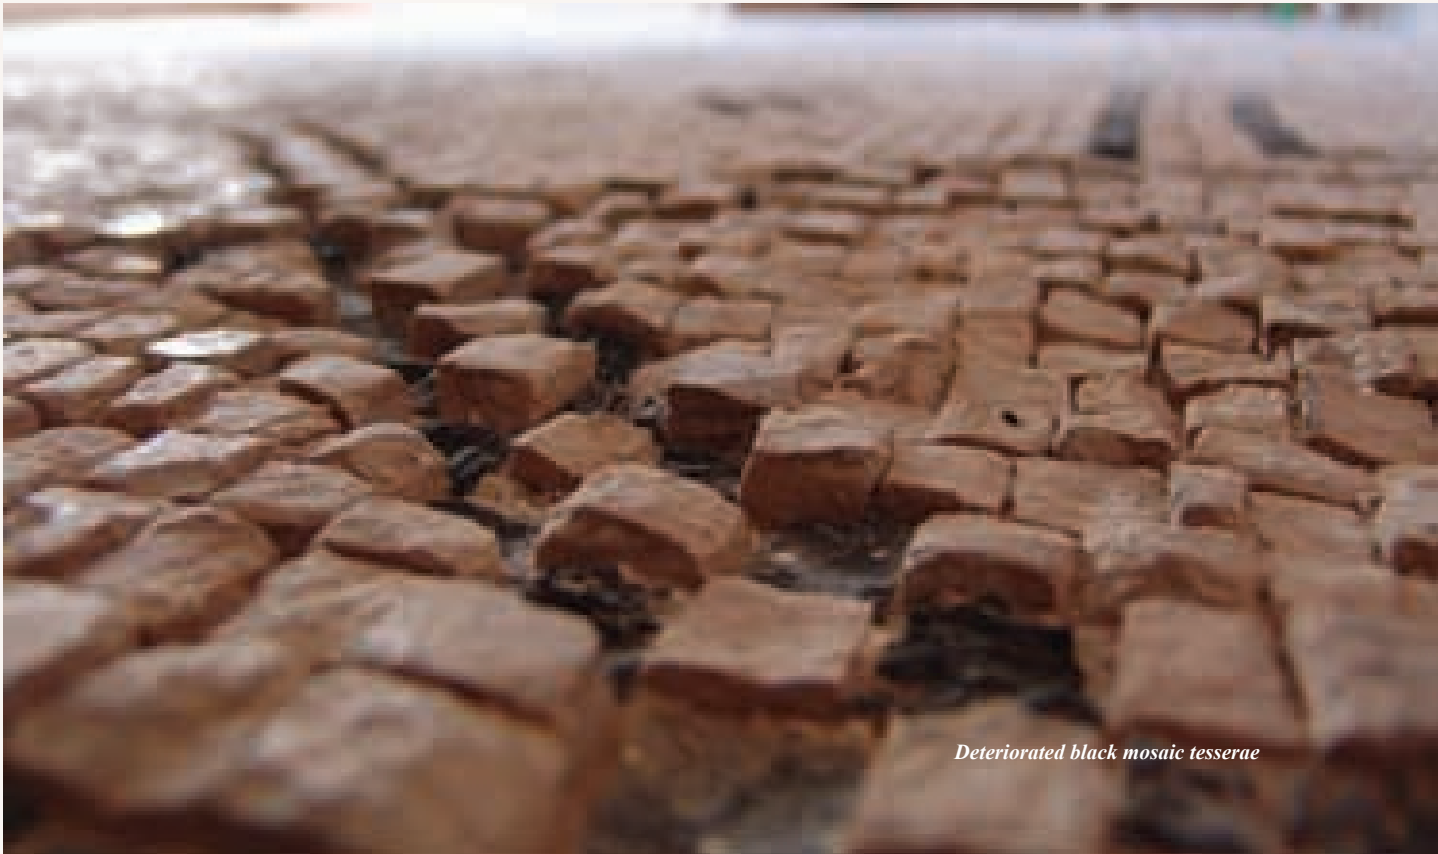
*Deteriorated black mosaic tesserae*

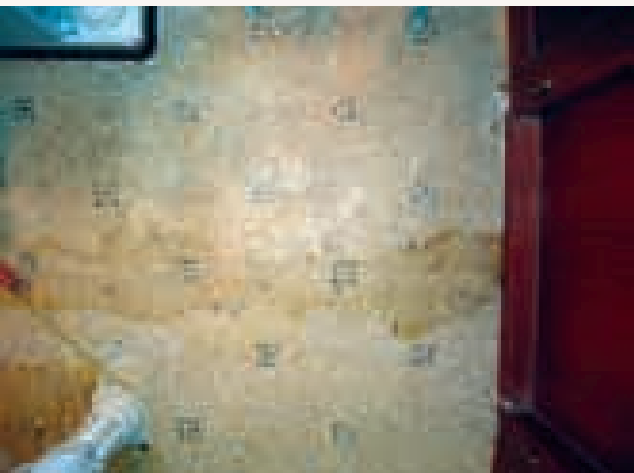
*Glue residues*

protect it. The glue altered the colour of the tesserae, especially the white ones, which absorbed the chemical elements of the glue and became yellow. The glue generated an insulating layer over the mosaic and caused further problems to tesserae.

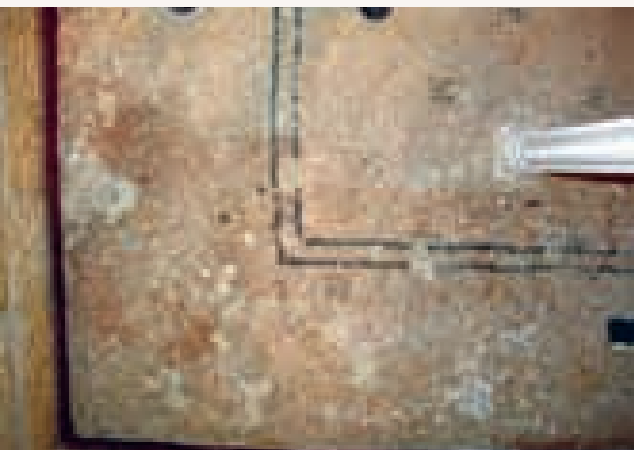
*Salt over the surface*

- When we removed the carpet inside the area closed by the iconostasis, we found a lot of salt over the floor, especially in the northeast corner. It was probably caused by water infiltrations from the outside through the walls or by lack of adequate ventilation.

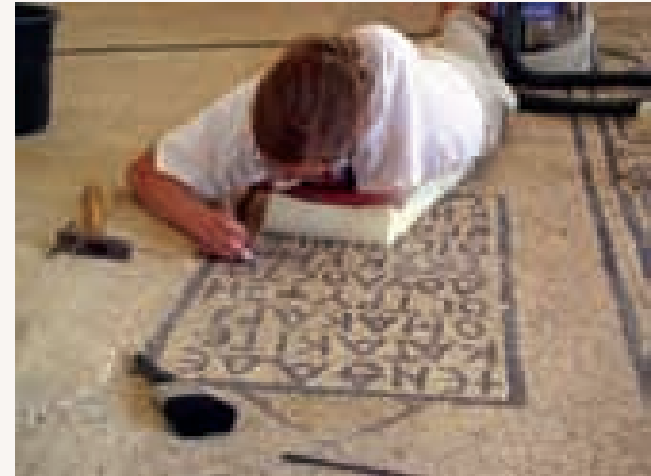
*Manual mechanical cleaning*

The operation started brushing up the mosaic floor with water to remove the dirt and decrease the hardship of the cement layer. Then we began to remove the white cement from the floor

using the manual mechanical method (hammer and chisel). The intervention was painful because the cement was hard and the tesserae, especially the black ones, were very fragile. The action has to be carried out with special attention, care and patience. We could not use blades as usual, because of the hardship of the cement layer. We were obliged to use a vibrating cutter.

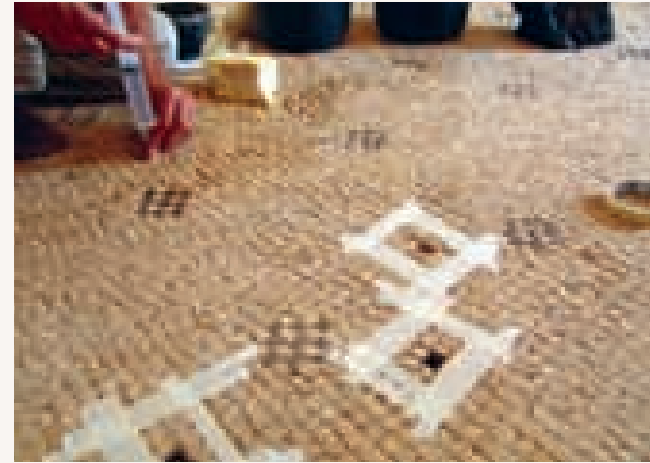
*Consolidation of swelled areas*

The reason to consolidate the mosaic floor is to improve the mechanical endurance of the degraded materials.<sup>21</sup> This kind of action increases also the chemical resistance of the materials. Some pre-consolidation activities were carried out before the cleaning, in the mosaic areas that were too fragile to afford the use of mechanical devices. Consolidation is used also to correct swellings.<sup>22</sup> We used *Primal*<sup>23</sup> and water at a dilution rate of 7-10 percent water, to consolidate the various layers of bedding by injections. In some areas we prepared a semi-liquid mix composed by hydraulic lime, stone powder and marble powder at 1:1:1, together with water and *Primal* at a dilution rate of 7-10 percent water.

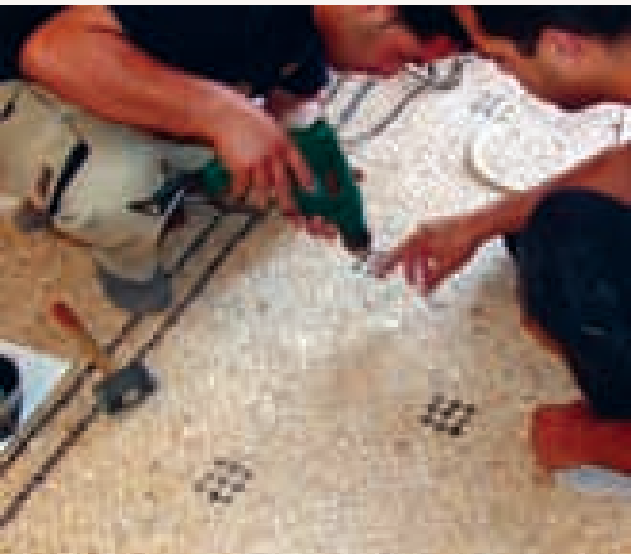
*Fixing swelled areas*

To repair the small swellings we produced a 3-millimetre diameter hole in the exact centre of it with a drill, then we cleaned the hole with water sprinkled inside with a syringe to remove all the internal filth, and finally we filled the hole with *Primal* and water at a dilution rate of 7 percent water.

To repair the large swellings, able to absorb the semi-liquid mortar, we delimited the edges of the swelling, fixed the entire area of the damaged mosaic with gauze and *Paraloid B72*<sup>24</sup> until it dried completely. To consolidate the area, we removed from four to six mosaic tesserae (numbered to facilitate putting them back in place). After cleaning the hole under the mosaic with a vacuum cleaner and removing the degraded mortar, we injected

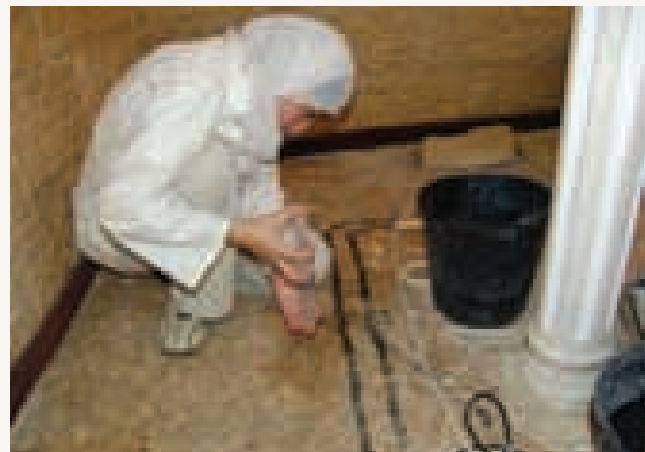
*Consolidation by injection*

We consolidated also fractured tesserae by injections of *Primal* and water at a dilution rate of 10 percent water. The operation was carried out after cleaning the mosaic floor first with the vacuum cleaner, soon after with simple water and then with *Primal* and water. Minutes later we washed again the floor to remove all chemical residues.

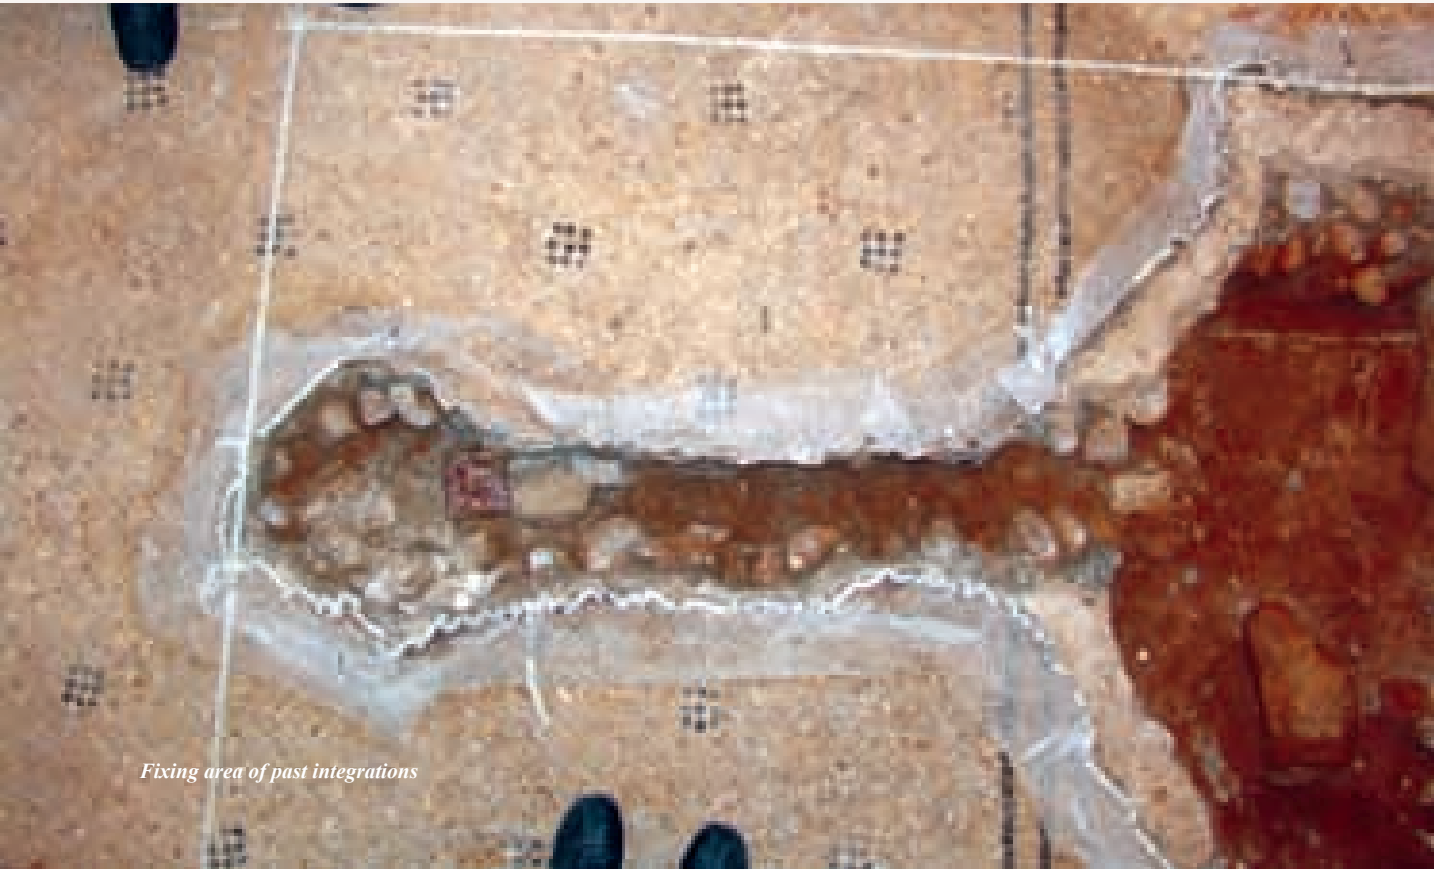
*Fixing area of past integrations*

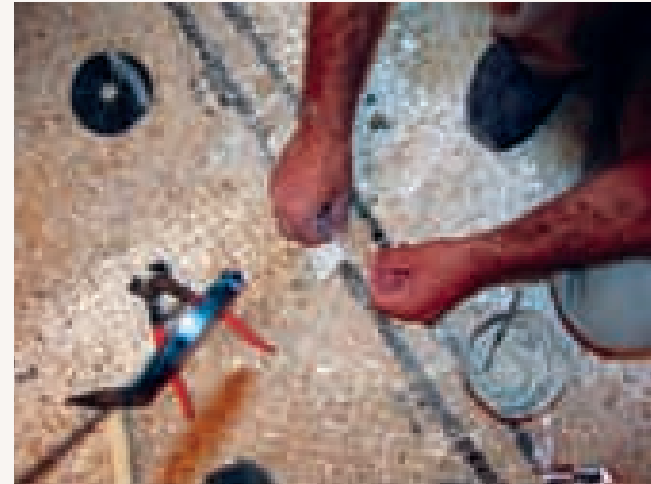
*Integration*

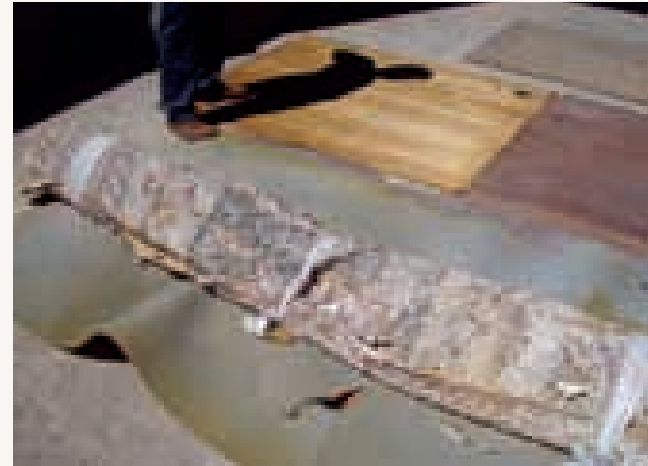
*The condition of the mosaic before the intervention*

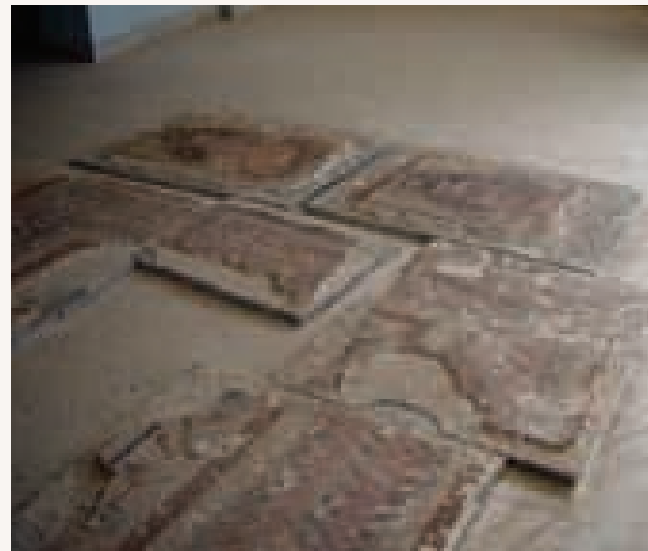
*The "Three Personifications mosaic" before last intervention*
