# Preserve the past and train the future

Project of training in cultural  
heritage conservation  
in East Jerusalem

Preserve the past and train the future  
Project of training in cultural heritage conservation in East Jerusalem

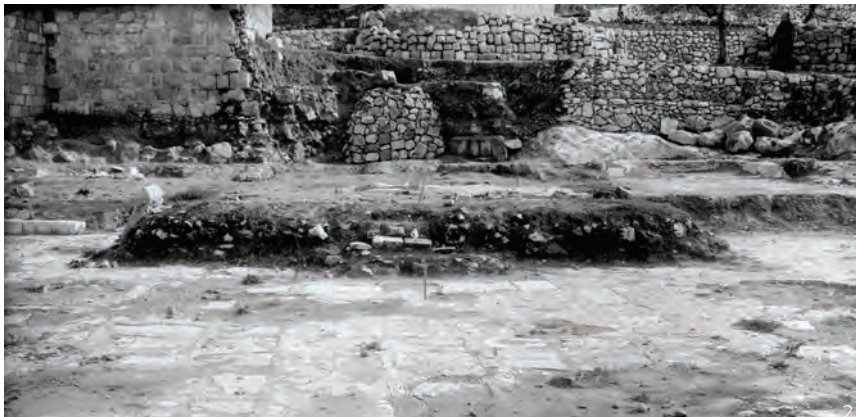
1. During the archaeological excavations in 1909
2. The floor of the Crusader church
3. Archaeological excavations of the Crusader church
4. Archaeological excavations of the Crusader church. Detail of a pilaster

Systematic excavations were able to begin in March 1909. The Franciscan Father Gaudenzio Orfali found himself facing the ruins of the 12th century church that had been constructed at the traditional site of the "Agony".

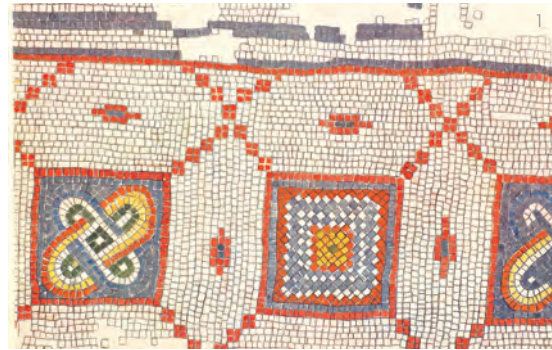
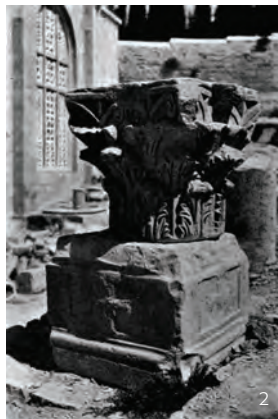
1. Fragments of Byzantine mosaic floor documented by father Orfali during the archaeological excavations
2. Capital of the Byzantine church found during excavations
3. Plan of the Byzantine church

In October 1919, during the excavation of the foundations for the new church, remains of mosaics belonging to an earlier church dating from the Byzantine period were discovered. The orientation of this church was significantly more to the northeast than that of the later medieval Crusader church: a design choice determined by the slope of the rocks. A natural rock formation, rising 35 cm above the level of the floor, formed the foundations of the central apse and was exposed to the veneration of the faithful. The Byzantine church had been of modest dimensions. The internal area was divided by two rows of seven

columns into a nave and two side aisles, all three of which ended in a semi-circular apses. A canal was dug along the external perimeter of the church to channel waters into a cistern constructed beneath the atrium. The church floor was covered by splendid mosaics, small fragments of which have been preserved. On the floor traces of a violent fire were evident, perhaps the one that destroyed the church in 614 during the Persian conquest of the city. The walls would have also been covered with mosaics, as a number of glazed mosaic tiles were found among the ruins. Based on studies of the ancient sources and the results of archaeological excavations, it would appear that the church was built during the reign of the Byzantine emperor Theodosius (379-395 AD).

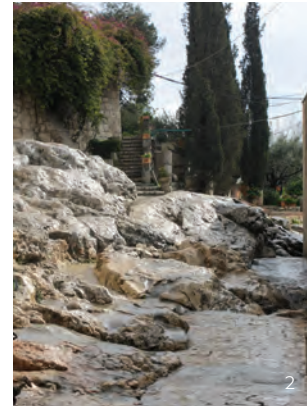
1. Plan of the Crusader church
2. The rocks enclosed in the apses of the Crusader church
3. The fresco fragment with an angel's head found during the archaeological excavations

The excavations in 1909 revealed the floor plan of the Crusader church, whose interior was separated by two rows of three cruciform pilasters into a nave and two aisles ending in three semicircular apses that enclosed the rock.

The presbytery, where the altar stood, had been built in the area of the nave. It rose 63 cm above the level of the floor and was surrounded by a perimeter wall. At the center of the presbytery the bare rock rose approximately 10 cm. Natural rock would also have been visible in the north and south apses.

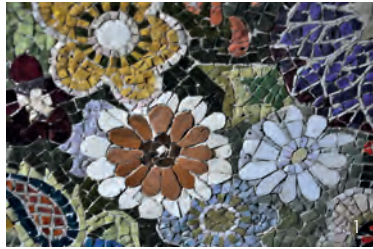
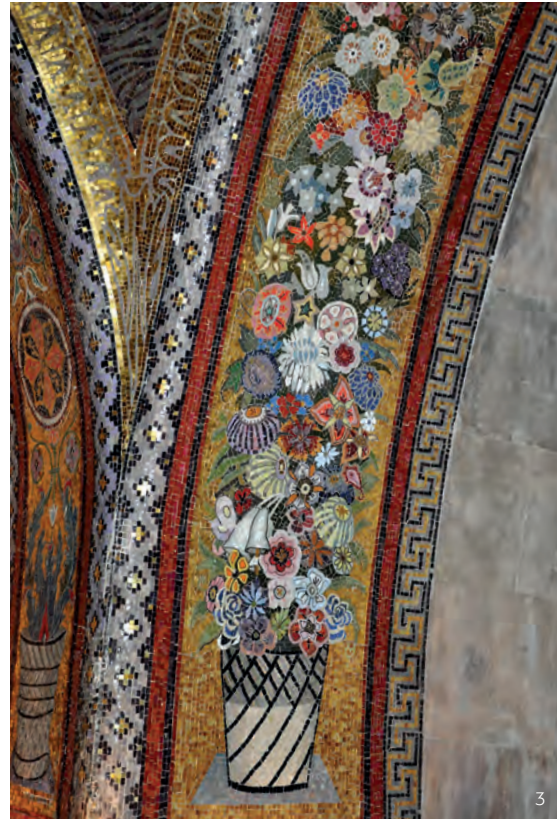
1. 2. Detail of internal mosaic decoration
3. Detail of the mosaics in a support arch
4. View of the modern floor mosaic of the north aisle

During the construction of the modern church pieces of floor mosaics of the Byzantine church emerged. The architect, inspired by the fragments, included them in its new floor and paved the rest of the space with new mosaics.

Other internal mosaic surfaces are the ceiling of the cupolas and the support arches, totaling about 800 square meters of mosaics. The wall mosaics are limited to the area of the central and lateral apses.

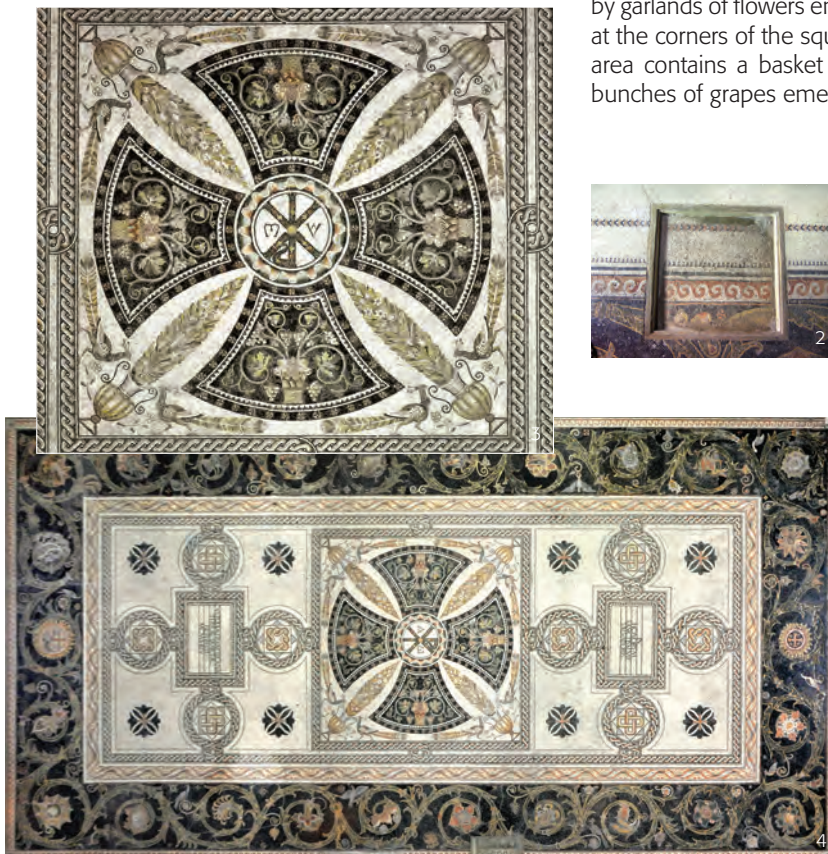
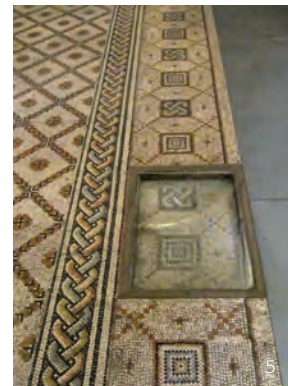
The floor mosaics in the side aisles are reproductions of the originals, of which the few fragments that have been found can be seen protected by glass. The fragments on the side aisles have geometric and floral designs. The outer frame consists of a row of irregular octagons, forming in each a central square and four surrounding oblong hexagons. In their interior a guilloche on a dark background framed a polychrome grid of overlapping rosebuds, the compartments enclosing a floret. The designs, against a white background, were made using red, yellow and black mosaic tiles. A small fragment found between the columns served as the inspiration for the mosaics there, with a guilloche strapwork forming adjacent hexagons and triangles. The few mosaic fragments preserved in the nave exhibited a rich floral decoration on a black background. The decoration in the nave was carried out by the artist Pietro D'Achiardi who was inspired by Roman-Byzantine models. The mosaic carpet in the nave is bordered by a decorative acanthus scroll and flowers on a black background. The field is divided into three parallel sections. The two outer sections have the same design,

a small central rectangle containing an inscription and four circles alongside the rectangle surrounded by a guilloche. On the corners of the two side sections are compound rosettes.

The design of the center section consists of a central Christogram and an outer circle divided into four areas by garlands of flowers emerging from amphoras located at the corners of the square, flanked by peacocks. Each area contains a basket from which a spiral plant and bunches of grapes emerge.

1. During conservation activities in the mosaic floor  
2. 3. 4. 5. Detail of floor mosaic

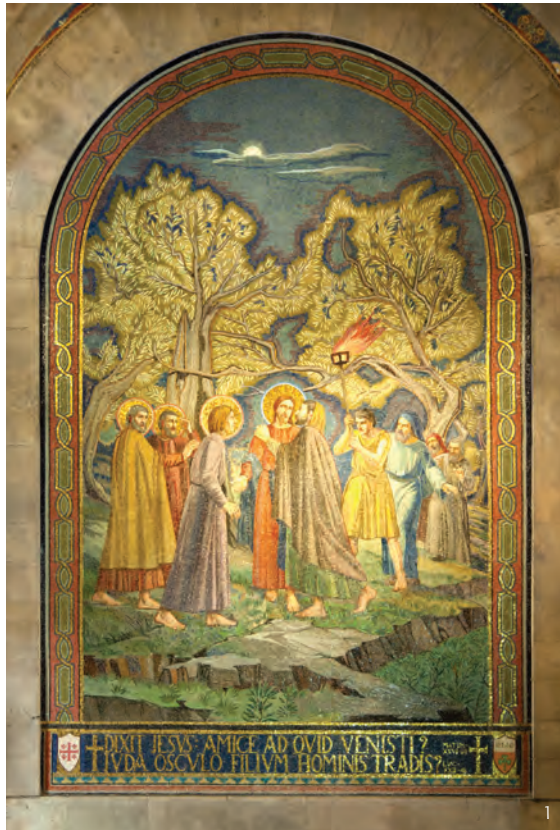
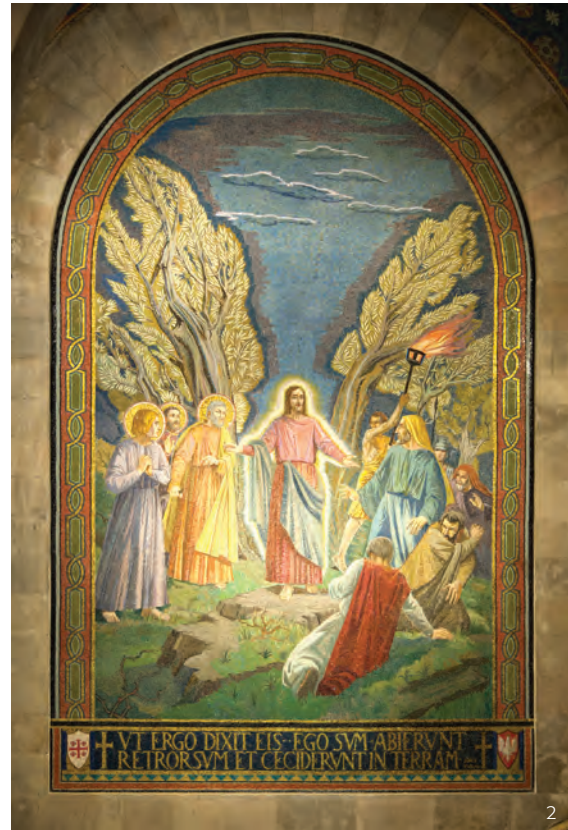
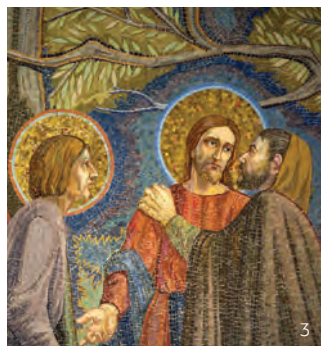
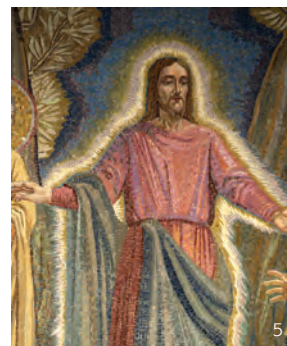
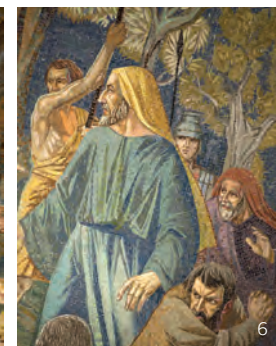
The mosaics decorating the apse were not made at the same time as those of the vaults but only several years later when, after a number of different artistic proposals had been rejected, they replaced the paintings that had decorated until then the place without much appreciation. The central apse mosaic was realized by Pietro D'Achiardi, the same artist of the vaults and floor mosaics.

The mosaics of the two side apses were drawn by Mario Barberis that replaced the earlier paintings made by the artist himself. The subject chosen by the Franciscans

for the decoration of the central apse is Christ suffering in the olive grove. On the apse to the right, the Kiss of Judas is represented and on the apse to the left the Ego Sum - the 'I am' that Jesus declared before the guards who were seeking to arrest him – was declared. The side mosaics depict various characters and faces made with great skill by Studio Monticelli of Rome.

1. The Kiss of Judas mosaic by Mario Barberis in the left side apse
2. Ego Sum mosaic by Mario Barberis in the right side apse
3. Detail of the Kiss of Judas mosaic
4. 5. 6. Detail of the Ego sum mosaic

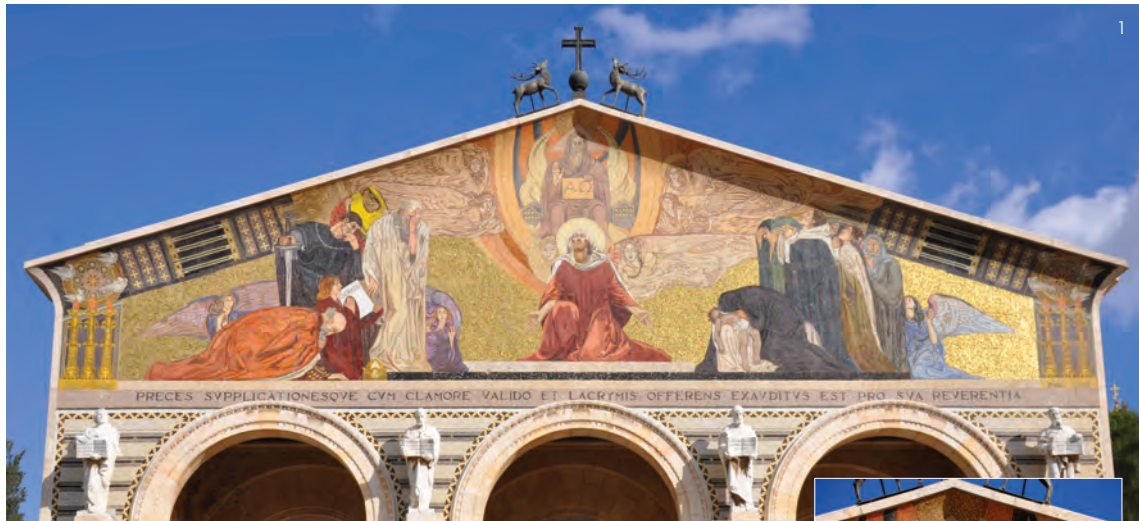
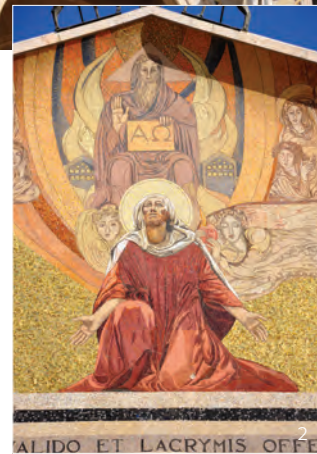
The mosaic on the tympanum represents the glorification of God through the sacrifice of the life of Jesus, who became intercessor for the prayers of all humanity. The mosaic was made by Giulio Bargellini after winning the competition in 1926 held for the purpose of choosing the best design for the tympanum. Jesus the mediator between God and man is portrayed: on his right are the wise and powerful who have recognized his superiority, while on the left are the weak and afflicted who are hoping for his intercession.

The lower part of the mosaic provides the background for the four statues of the evangelists. The mosaic is composed of glass pastes of various colors, various shades of gold, and stones.

1. The tympanum mosaic in the present church facade
2. Detail of the tympanum mosaic
3. Detail of the tympanum mosaic
4. Detail of the tympanum mosaic
5. Conservation work in the tympanum mosaic of the façade

The same problems were present also on the walls of the apses, on the floor and in the tympanum, which was also damaged by bullets.

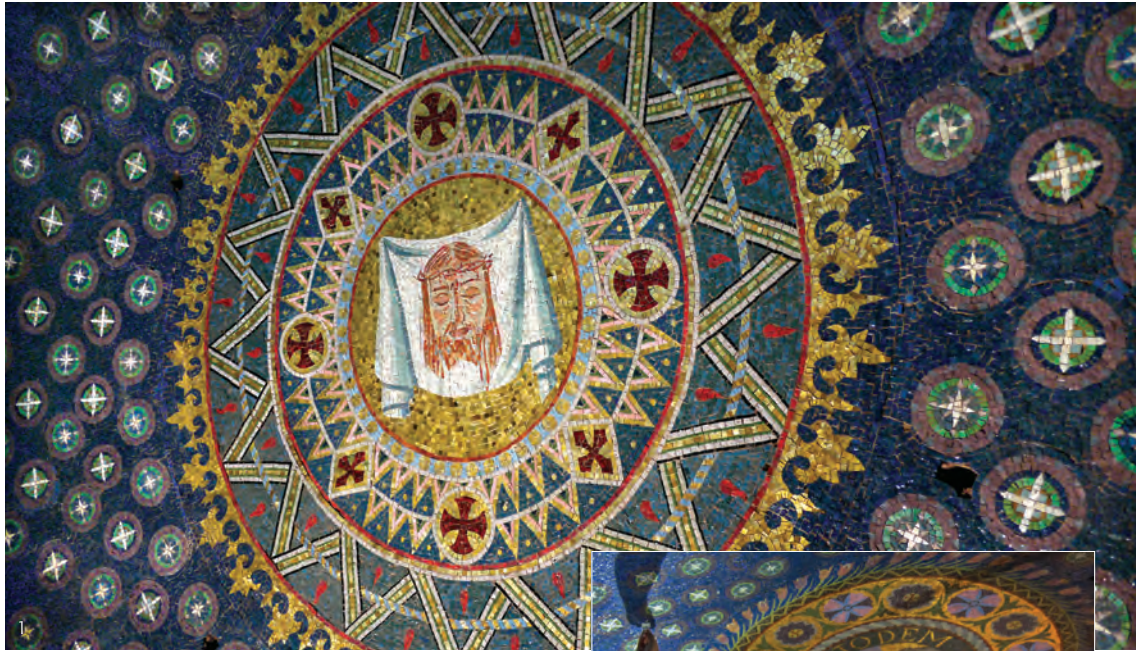
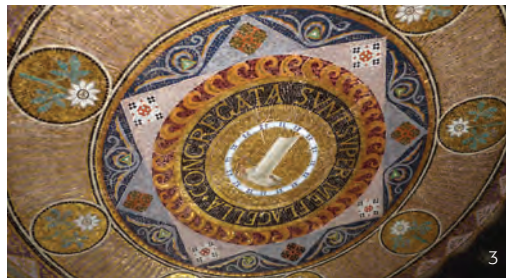
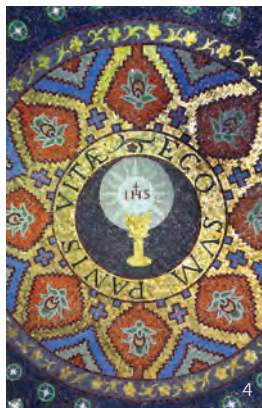
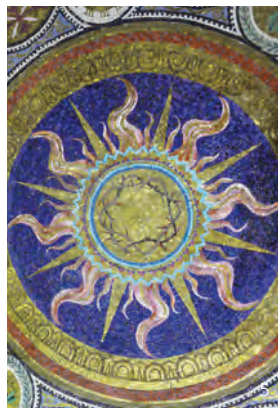
Christian symbols are placed in each vault. On a background of gold mosaic tiles in the center of the vault, symbols of Christianity stand out against the blue of the night, including the coat of arms of the Franciscan Order, the chalice with the Host and the IHS Monogram (an abbreviation of Christ's name), the Cross of Jerusalem and the typical symbols of the Passion. The symbols of the Passion are the three nails from the Cross, the Veil of Veronica with which she wiped Jesus' face, the Column of the Flagellation, the Tomb, the Cross, the tunic and the dice thrown by the soldiers, the lance with which Jesus was struck and the sponge soaked in vinegar on a sprig of hyssop that was given to Jesus to drink, and lastly the Crown of Thorns.

These are all located at the center of concentric squares decorated with floral and geometric designs and next to each symbol, apart from the Veil of Veronica, is an inscription describing it.

1, 2, 3, 4, 5, 6. Christian symbols in the vault mosaics

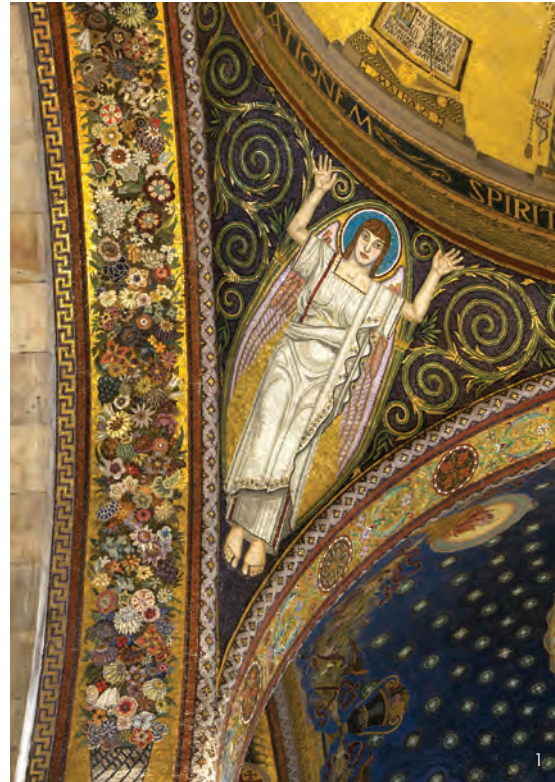
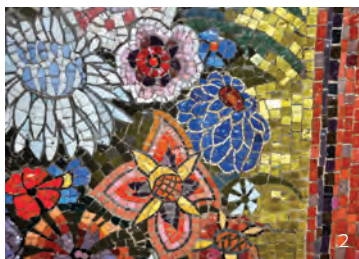
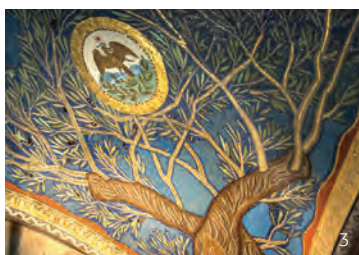
The vaults are decorated with olive trees whose trunks and twisted branches emerge from the capitals of the columns, with their foliage extending towards the center against the blue background of the night sky. The colors used for the trunks are black, gray, and dark and light green. The artist sought to give a sense of antiquity to the trees. In each vault the foliage incorporates four circles that contain information on the donor countries and the date of completion of the mosaics and which extend towards the center of the arches where the vases and birds are located. Additional plants are to be found in other areas of the vaults, notably a wreath of laurel with its fruits which surrounds the lower part of the center dome, and acanthus scrolls alongside the four figures of angels supporting the dome. In the two side vaults alongside the center dome, in place of olive branches there are garlands of flowers and various fruits.

The intrados (inner curves) of the arches of the central dome and the vault above the entrance are covered with a decorative band of flowers emerging from a basket. The band of flowers form one of the most beautiful and elegant elements of the entire mosaic decoration.

The ceilings in the two side apses are decorated with flowers having the form of a circle that gradually becomes smaller towards the center of the vault. Other floral decorations are scattered throughout the intrados of the arches of the other vaults.

Various types of fruits, vegetables and cereals can be seen in the interior of the vases, which are also decorated with plant leaves and flowers of various colors – red, white, brown, etc. Frequently to be recognized among these elements are pears, figs, white and black

grapes, and pomegranates. Also to be observed are apples, chestnuts, cucumbers, plums, apricots, lemons, bananas, oranges, cherries, and ears of wheat and corn. In some cases cross-sections of fruits are presented so that their interiors can be seen.

1. Flowers in the dome arch  
2, 3, 4. Detail of floral decoration in the vault mosaics

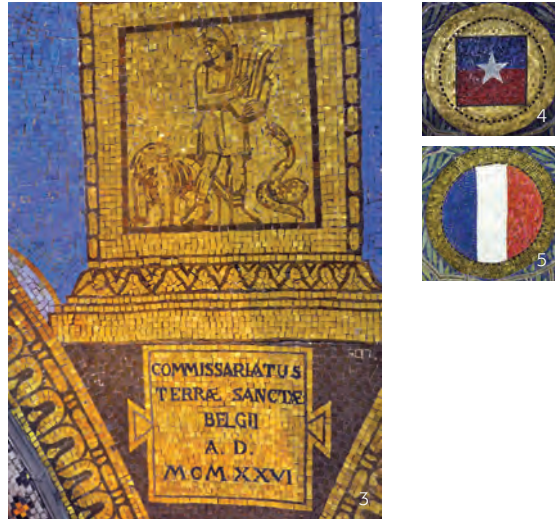
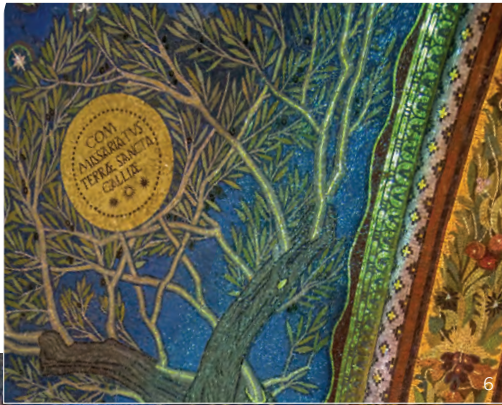
In the dome mosaics, apart from those in the central and two side domes, one can distinguish the symbols of the different countries that contributed to the project. The same symbol has been placed inside two circles in each dome, while a third circle contains the name of the Commissariat of the Holy Land that contributed. In the left aisle the symbols of Mexico, Chile and Brazil can be seen, in the nave those of the United Kingdom, Spain and France, and in the right aisle those of the USA, Germany and Canada. There is no symbol in the central dome, to which Italy contributed, but instead the name of the Commissariat of Naples is inscribed in a golden circle. On the aisle to the left of the central dome, in a golden tabula ansata, is the name of the Commissariat of Argentina, while in the right aisle, is the name of the Commissariat of Belgium. The symbols of Ireland, Poland and Hungary have been placed in the lower right of the mosaics in the left, right and central apses, respectively. Australia undertook to contribute the iron railing around the rock.

1. Symbol of Mexico in the vault mosaics
2. The circle that mentions Mexican contribution
3. The tabula ansata that mentions Belgian contribution
4. Symbol of Chile in the vault mosaics
5. Symbol of France in the vault mosaics
6. The circle that mentions Chilean contribution
7. General view of vault mosaics

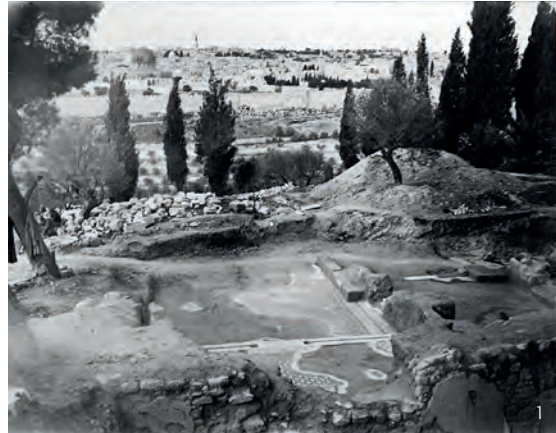
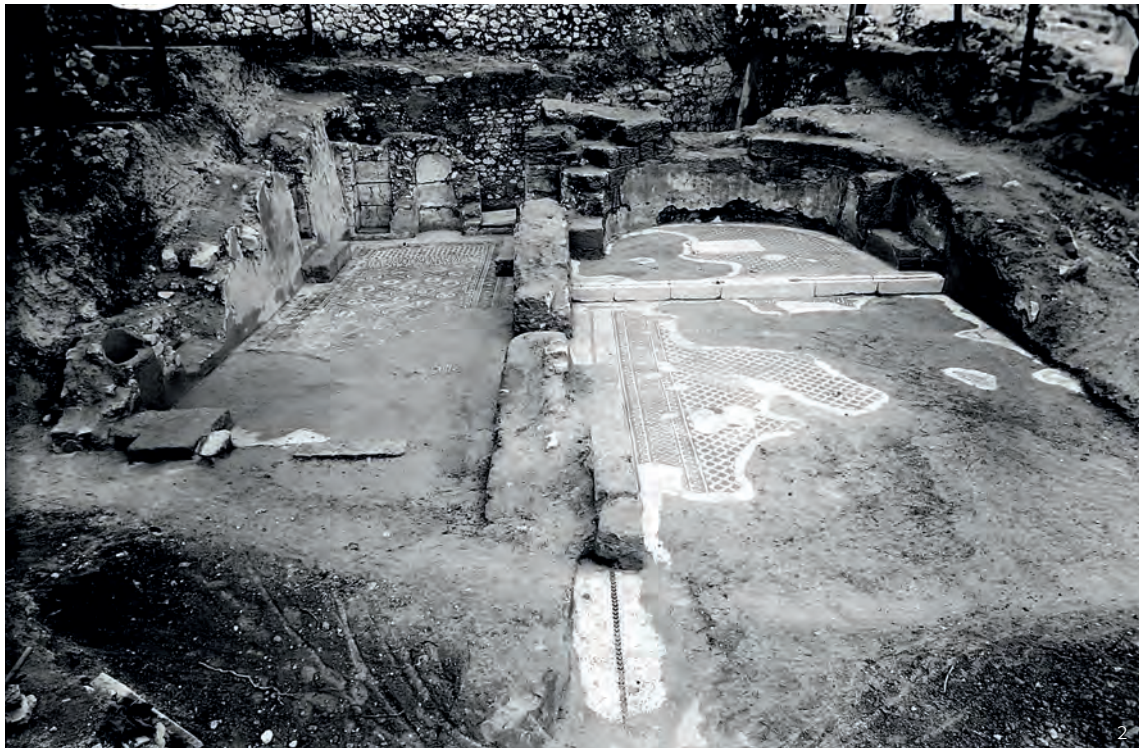
The excavations exposed a large necropolis of various historical periods, confirming that the area was devoted to burials with few residential buildings. In November 1954, a mosaic fragment belonging to a Byzantine monastery was discovered, probably built in the seventh century AD and remained in use until the eight century AD.

The fragment was part of the mosaic floor of a chapel with an apse oriented to the east flanked by a second area, called the oratory, with a narrow and elongated layout and with a semicircular niche also oriented to the east. An opening on the side of the recess led to the

east with an irregular room, carved into the rock, with a stone bench along its walls and an oven.

A cloister paved by stones stood to the northwest of the church and was originally surrounded by columns - two of which have survived to the south - and rooms. A cistern in the courtyard had two openings, one to the east and the other to the west. A vaulted cistern was excavated in the middle of the west side of the cloister and it is now under the stairs. Further north, there is a presser paved with white mosaics.

1. Discovery of the chapel during excavations
2. The chapel and the oratory with surviving mosaics

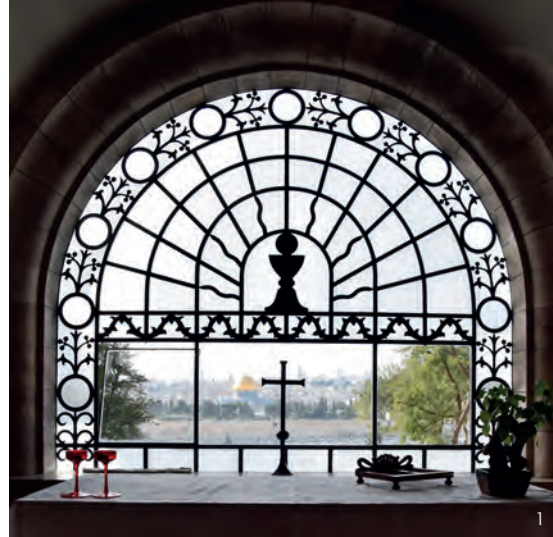
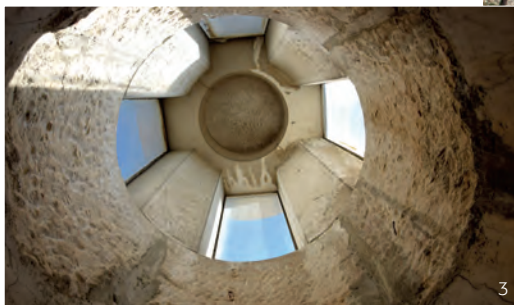
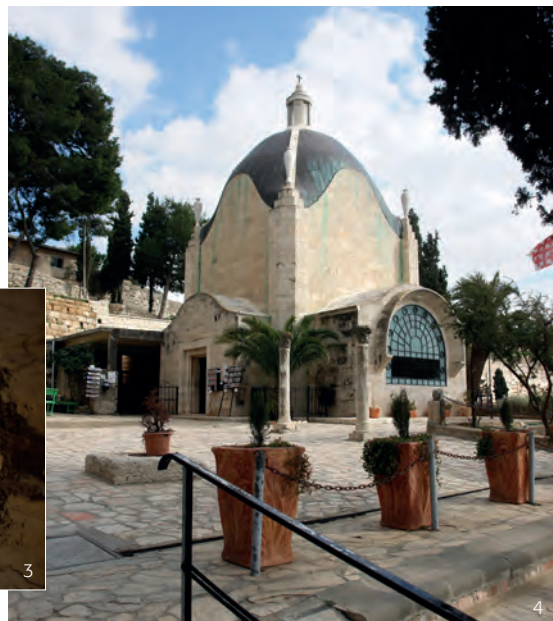
The modern church was built over the remains of the Byzantine church by the architect Antonio Barluzzi in 1955, before the conclusion of the excavation. Barluzzi was the same architect that worked on the church of Gethsemane. Dominus Flevit was his last work in the Holy Land.

The plan of the church has a cruciform shape and includes in the east the apse of the original church. The central square plan is covered by a circular vault. The altar is located on the west side and from its back a large window allows an impressive view of the city of Jerusalem, which commemorates the Gospel passage. From the outside you can see the three protruding south, east, and north sides. In the corners of the square

there are four pillars with amphoras on the top. The overall shape of the church echoes a teardrop, inspired by the Gospel passage. The roof is covered with lead plates, adorned with a roof lantern that allows light to enter and reflect on the mosaics.

1. The view at Jerusalem from the arched window behind the altar of the church
2. Plan of the archaeological remains: the monastery and the tombs
3. Detail of the roof lantern from inside
4. External general view of the church

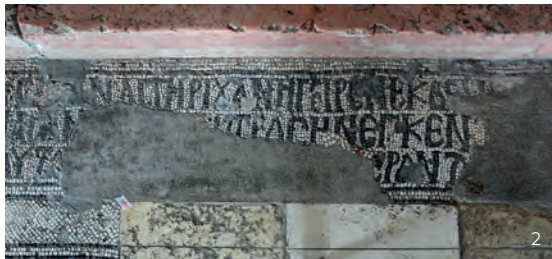
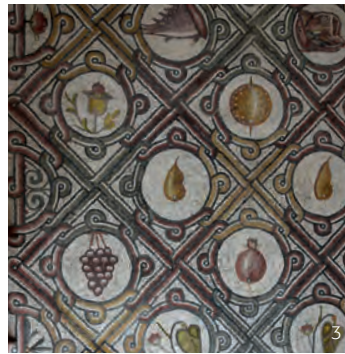
1. Inscription in the oratory
2. Inscription in the church
3. Fruits, flowers and fishes in the mosaic of the oratory
4. Red Grape in the mosaic of the oratory
5. Pomegranate in the mosaic of the oratory

The subjects represented in the Dominus Flevit mosaics are inscriptions, vegetable elements, and fish. There are two inscriptions written in Greek and are rectangular in shape. The first is in front of the apse of the chapel. The letters are black on white background. It is a fragmented dedicatory inscription. The second inscription is in the second part to the east of the oratory mosaic. It is in black letter on white background, naming Simeon as a builder of the chapel and a dedication to the Lord Jesus and to the monks, George and Domezio. The only surviving animal is a fish, which is divided into two medallions. In one there is the head, which was damaged in antiquity and rebuilt at the time of the excavations. The other medallion contains the tail. Other fishes may have been damaged in antiquity but at the time of the excavations they were not identified as such and so reconstructed as vegetable elements.

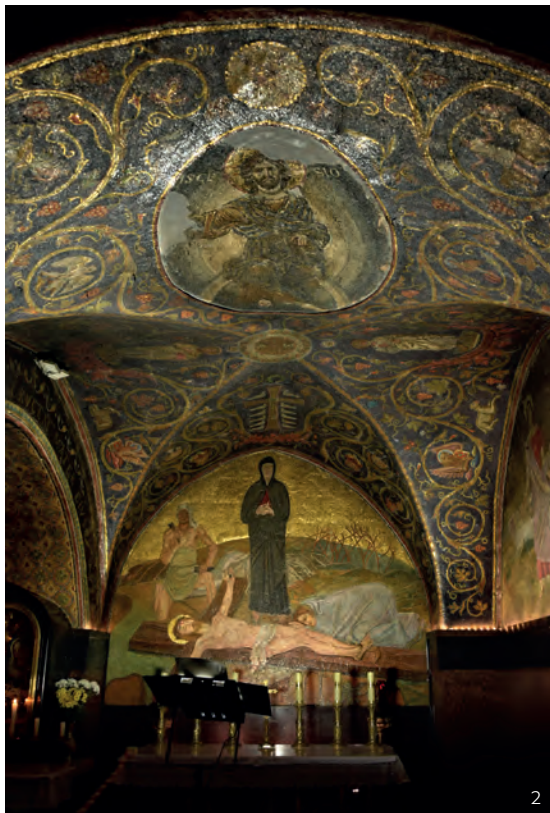
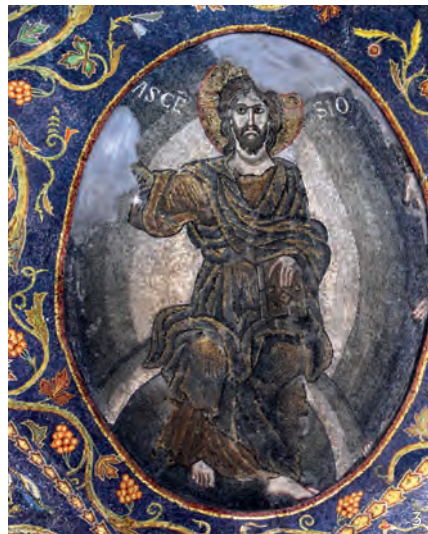
The Chapel of the Nailing to the Cross has a rectangular plan covered by two cross vaults. Before 1928, the Chapel was in poor condition. The floor was ruined and the walls and vaults were covered with plaster. Only a fragment of the medieval mosaic decoration representing the Ascension remained on the ceiling. The Franciscan Custody entrusted the restoration to the Italian architect Barluzzi, who worked on it from 1928 to 1937. The work of Barluzzi did not involve structural changes but only decorative interventions on the floor, the walls, and vaults.

1. Detail of mosaic in the Calvary Chapel
2. General view of the Calvary Chapel
3. Mosaic fragment of the Ascension from Crusader period

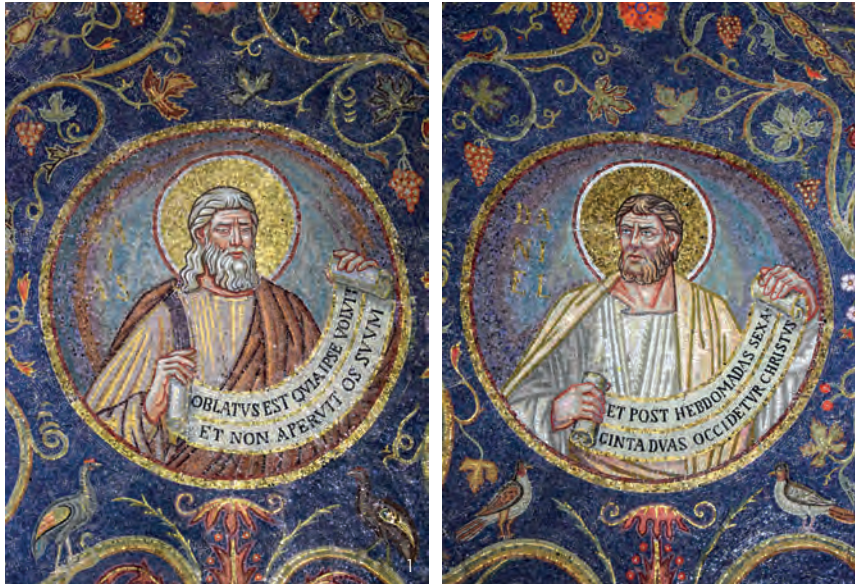
1. Prophet Isaiah in the western cross vault
2. Prophet Daniel in the western cross vault
3. Detail of wall mosaic behind the altar
4. Decoration of the arch
5. Detail of the lunette mosaic in the south
6. 7. 8. Details of the mosaic of the ceiling

The mosaic of the ceiling covers all surfaces of the two cross vaults. It was realized by Studio Monticelli following the drawings of artist Pietro d'Achiardi. The cross vaults are composed of four panels decorated with racemes and grapes volutes on a blue background. Each panel contains four racemes. Starting from the base of the panels two of the racemes go towards the corners and the other two go towards the middle of the vault. They create volutes that decrease in volume going towards the corners and the middle of the vault. The volutes contain Christian symbols and biblical figures. Fruits, birds and other animals are included in the volutes and over the racemes.

In the western cross vault, the prophets Zacaria, Daniel, David and Isaiah are located in a circle in the middle of each panel.

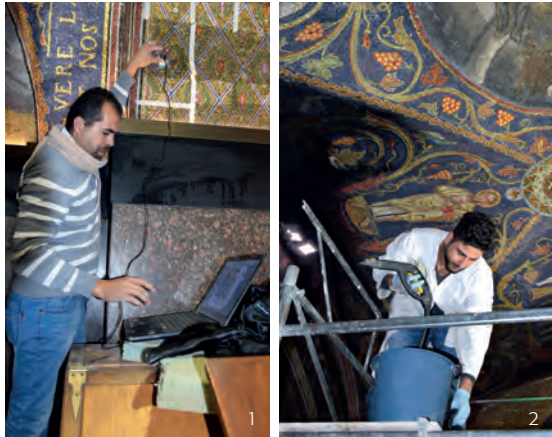
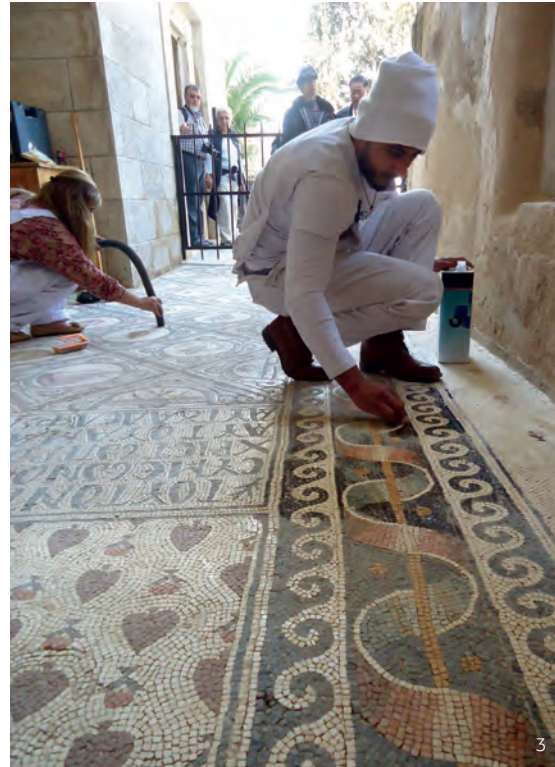
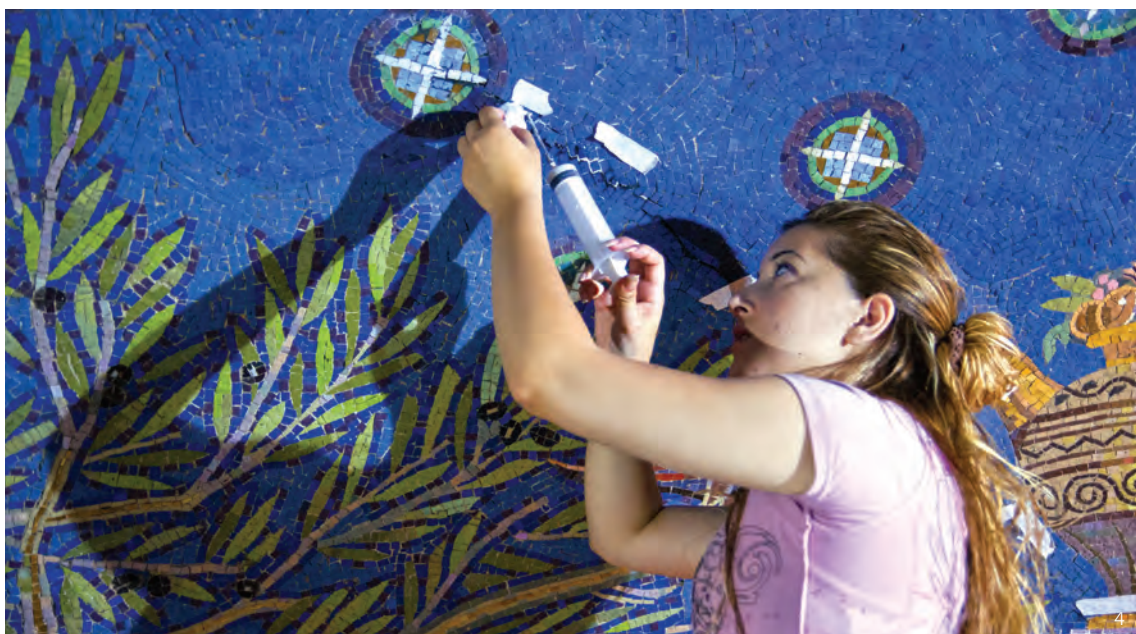
1. During the microscope analysis in the Calvary chapel
2. Conservation works in the Calvary chapel
3. Conservation works in the oratory of Dominus Flevit
4. Consolidation works in the Gethsemane church

The mosaics in the Calvary Chapel of the Holy Sepulchre had several problems caused by the use of candles. We analyzed the mosaics using a microscope to understand the different kinds of residue. We found detachments in the original support. We cleaned the modern mosaic with steam and consolidated it by injection.

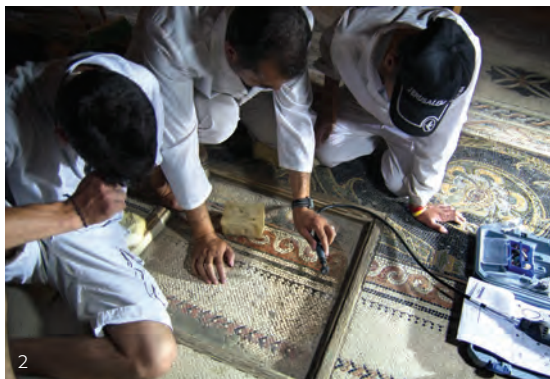
The problems found in the ceiling were:

- partial loss of mosaics due to water infiltration from the roof
- a layer of grime eroding the enamel and gold mosaic tesserae
- swellings and detachments from the original support
- two kinds of lacunae, one less than 5 tesserae and the other more than 5 tesserae
- lacunae filled by cement
- cracks
- varnish
- salt caused by water infiltration
- previous restoration was badly executed
- electrical cables and iron clips
- fractured tesserae
- cement residues
- moss

1. Cleaning the mosaic surface in the central dome in Gethsemane church

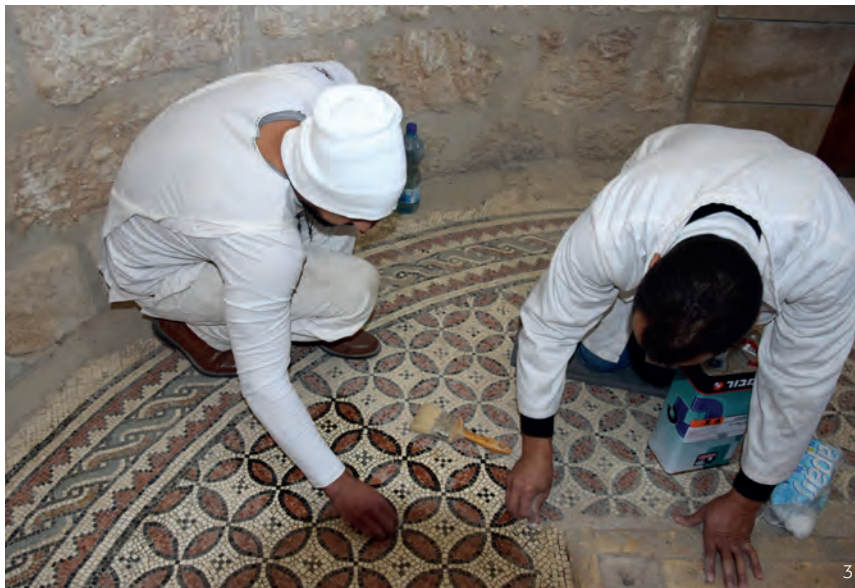
1. State of conservation of the lifted mosaic floor of Dominus Flevit
2. State of conservation of the mosaic in the ceiling of Dominus Flevit church
3. Conservation works in the apse of the Dominus Flevit church

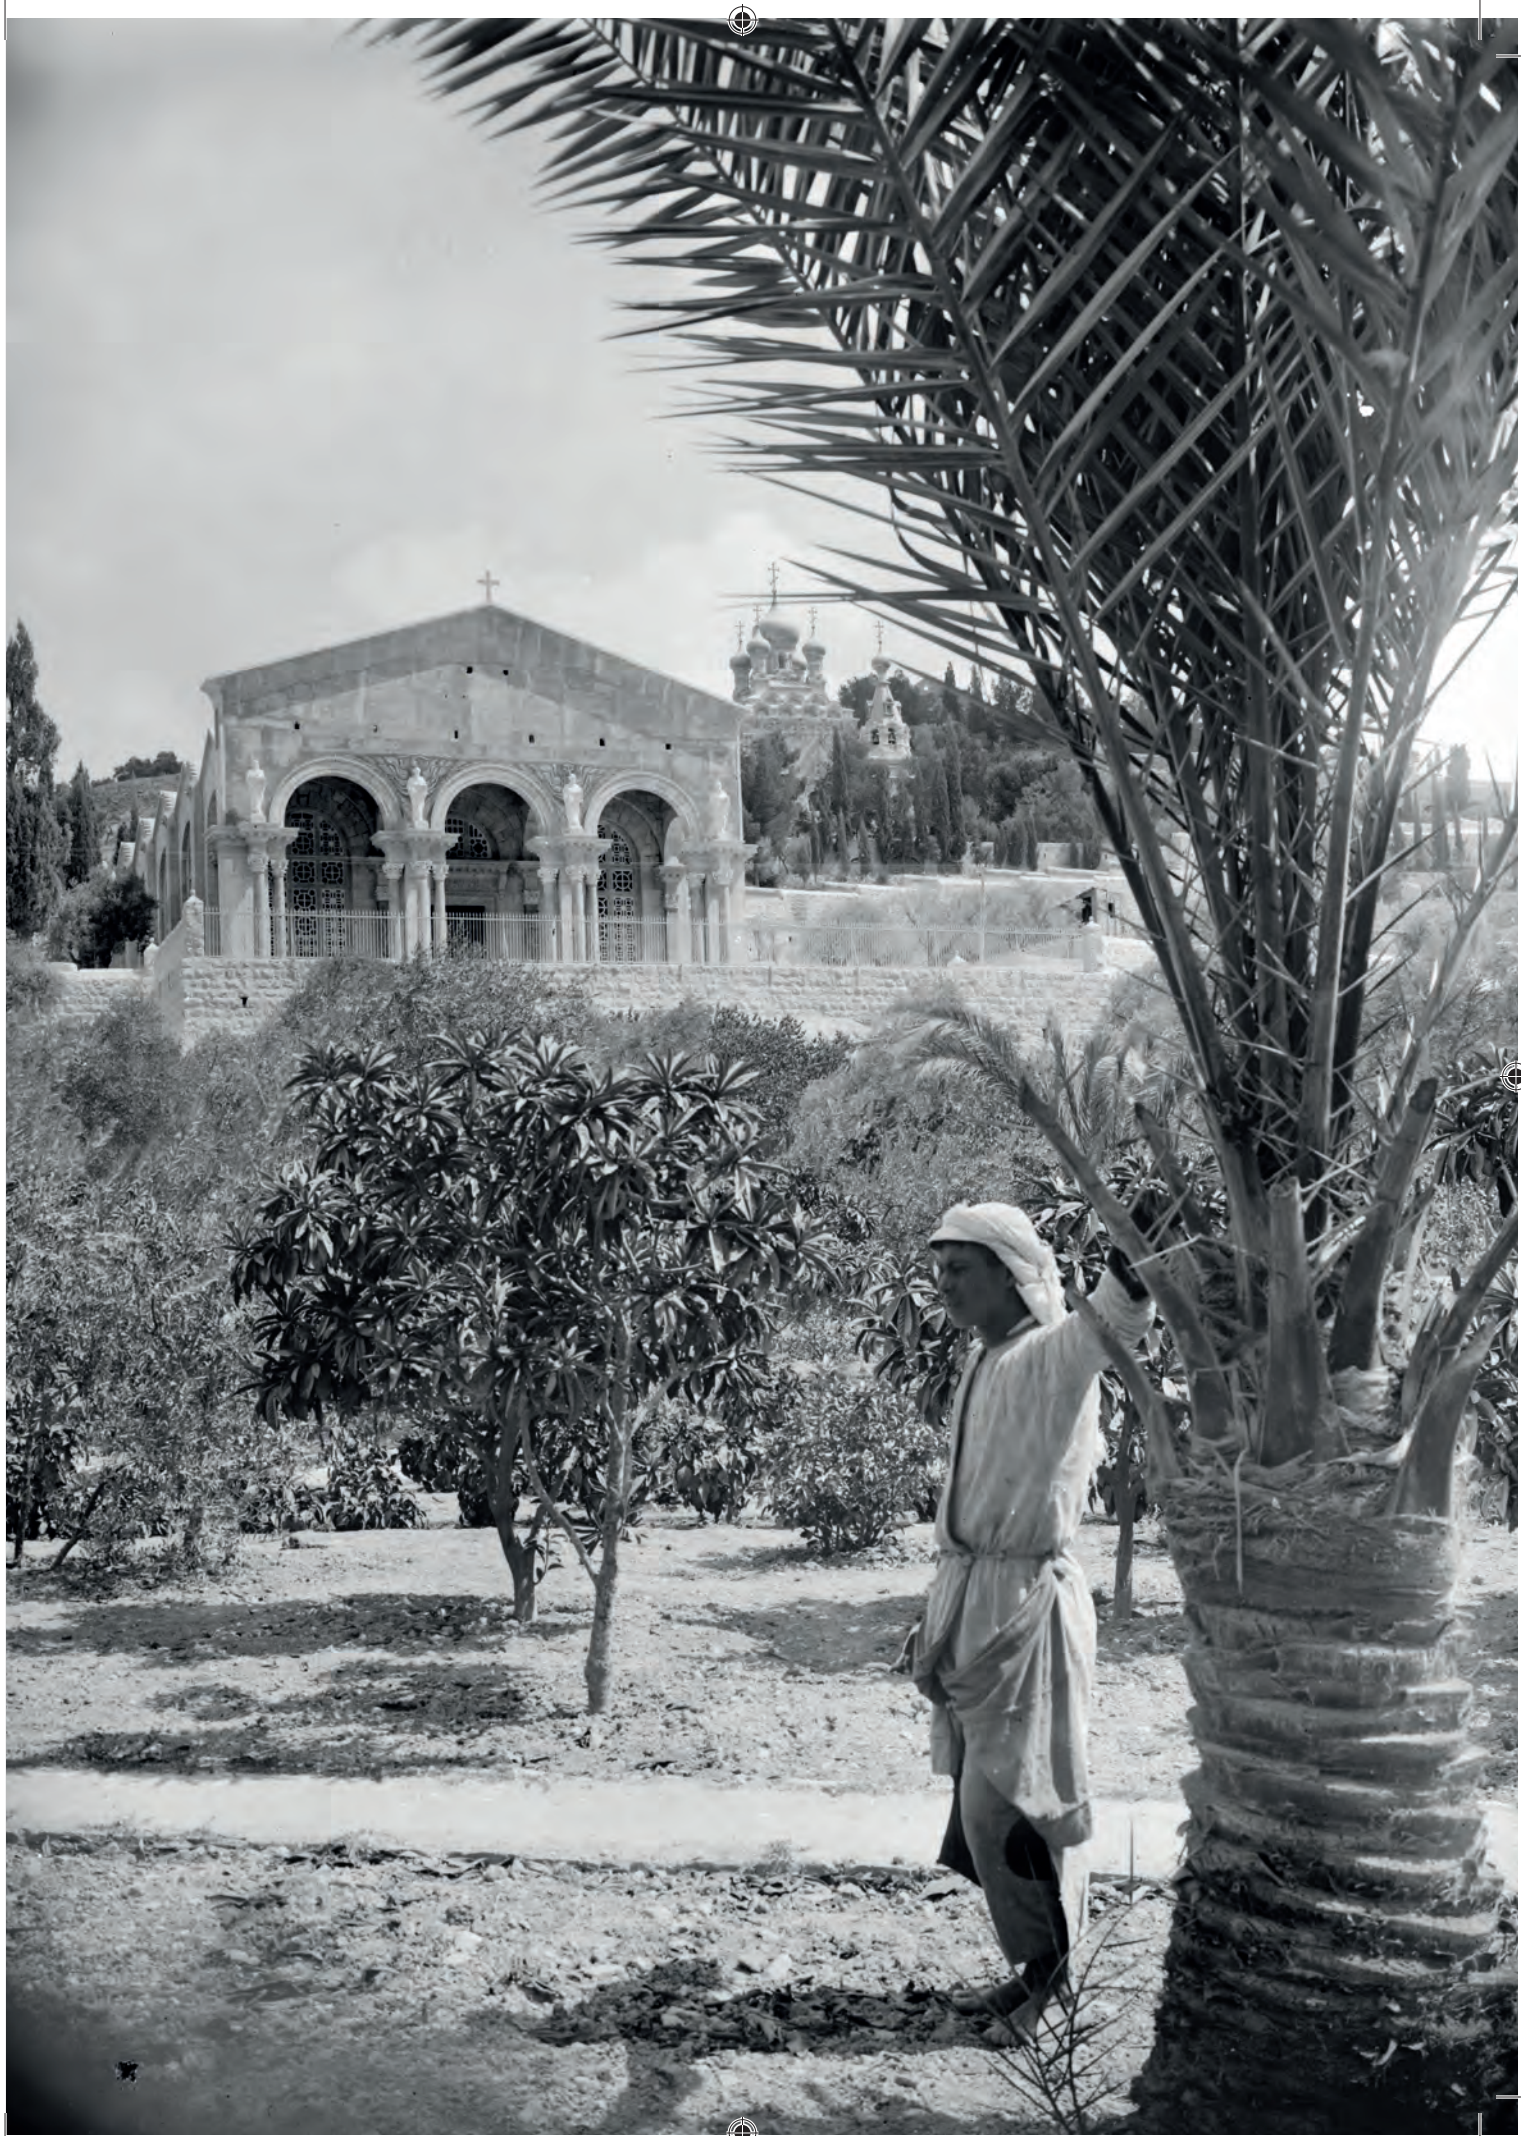
Sheet No: 24  
 Sheet Name: South elevation  
 Date: August 2013  
 Prepared by: Arch Osama Hamdan, Arch Najati Fitiani

- black patina
- rust residues
- microorganism in the water drainages
- paint residues
- broken stones

Thematic chart of intervention on the tympan in Gethsemane church

Rust residues
-

Broken stone

- mechanical cleaning by water
- cleaning the microorganism
- put a protection layer
- restoration and fixing of broken stones by epoxy resin
- application of waterproof coating

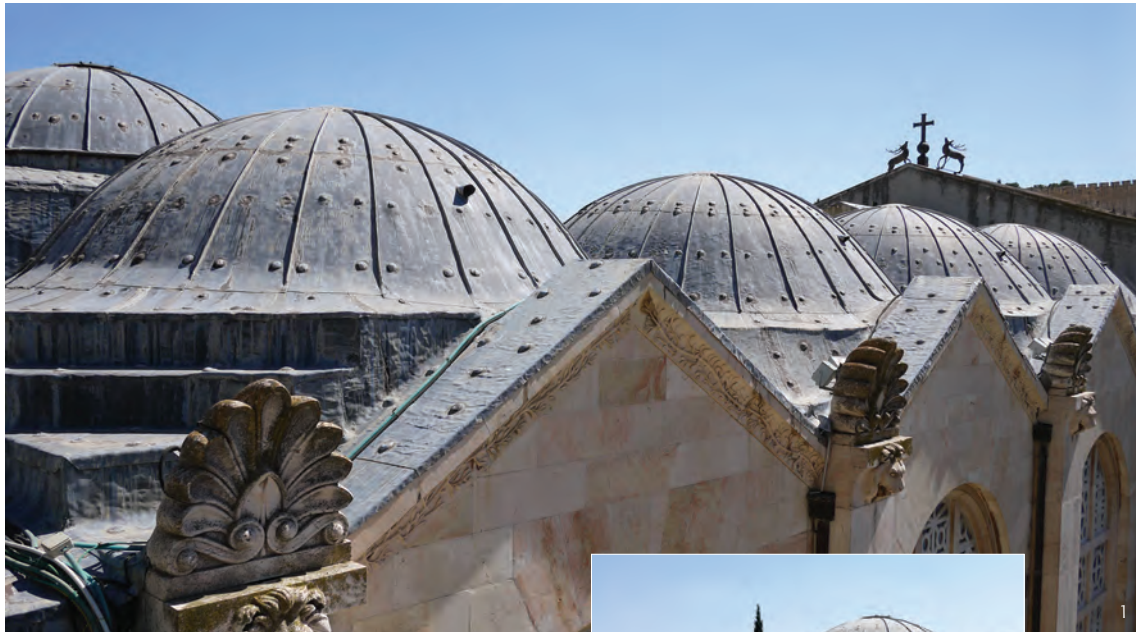
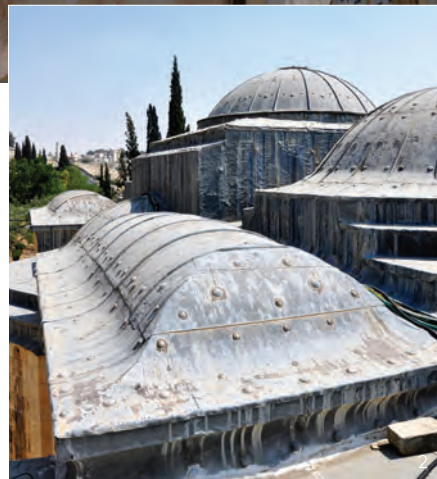
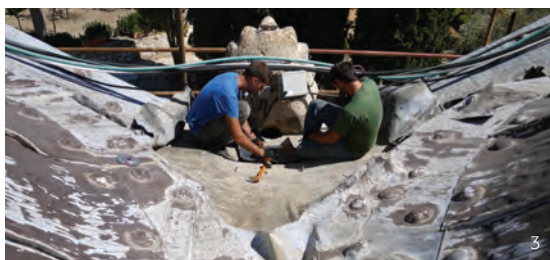
1. The roof of the present church
  2. Degrade in the roof
  3. Restoring the lead sheets
  4. Top plan
- ◀ View from the Garden of Olives

Restoration of the roof of the church of Gethsemane was required in order to solve the problem of damage to the mosaics resulting from water leaking through the roof. For the roof construction the architect Barluzzi had taken his inspiration from those of Byzantine churches. The ceiling consists of a double structure, a lower mosaic-covered vault facing the interior of the church and an upper, outward-facing dome covered with sheets of lead. The lead work on the roof is a work of great skill, but over time it has suffered damage due to the weather and the installation of various pieces of equipment, along with the fact that the water drainage pipe was too small for the amount of rainwater. The roof restoration has solved the drainage problems and replaced the lead sheets damaged over time. The work was carried out by an Italian company having expertise in this specific technology and material. Local workers were employed, providing them the opportunity to learn new skills.
